Aquatic Restoration

George Washington and Jefferson NF

Dawn Kirk
Fisheries Biologist
US Forest Service

Restoration Project Case Studies

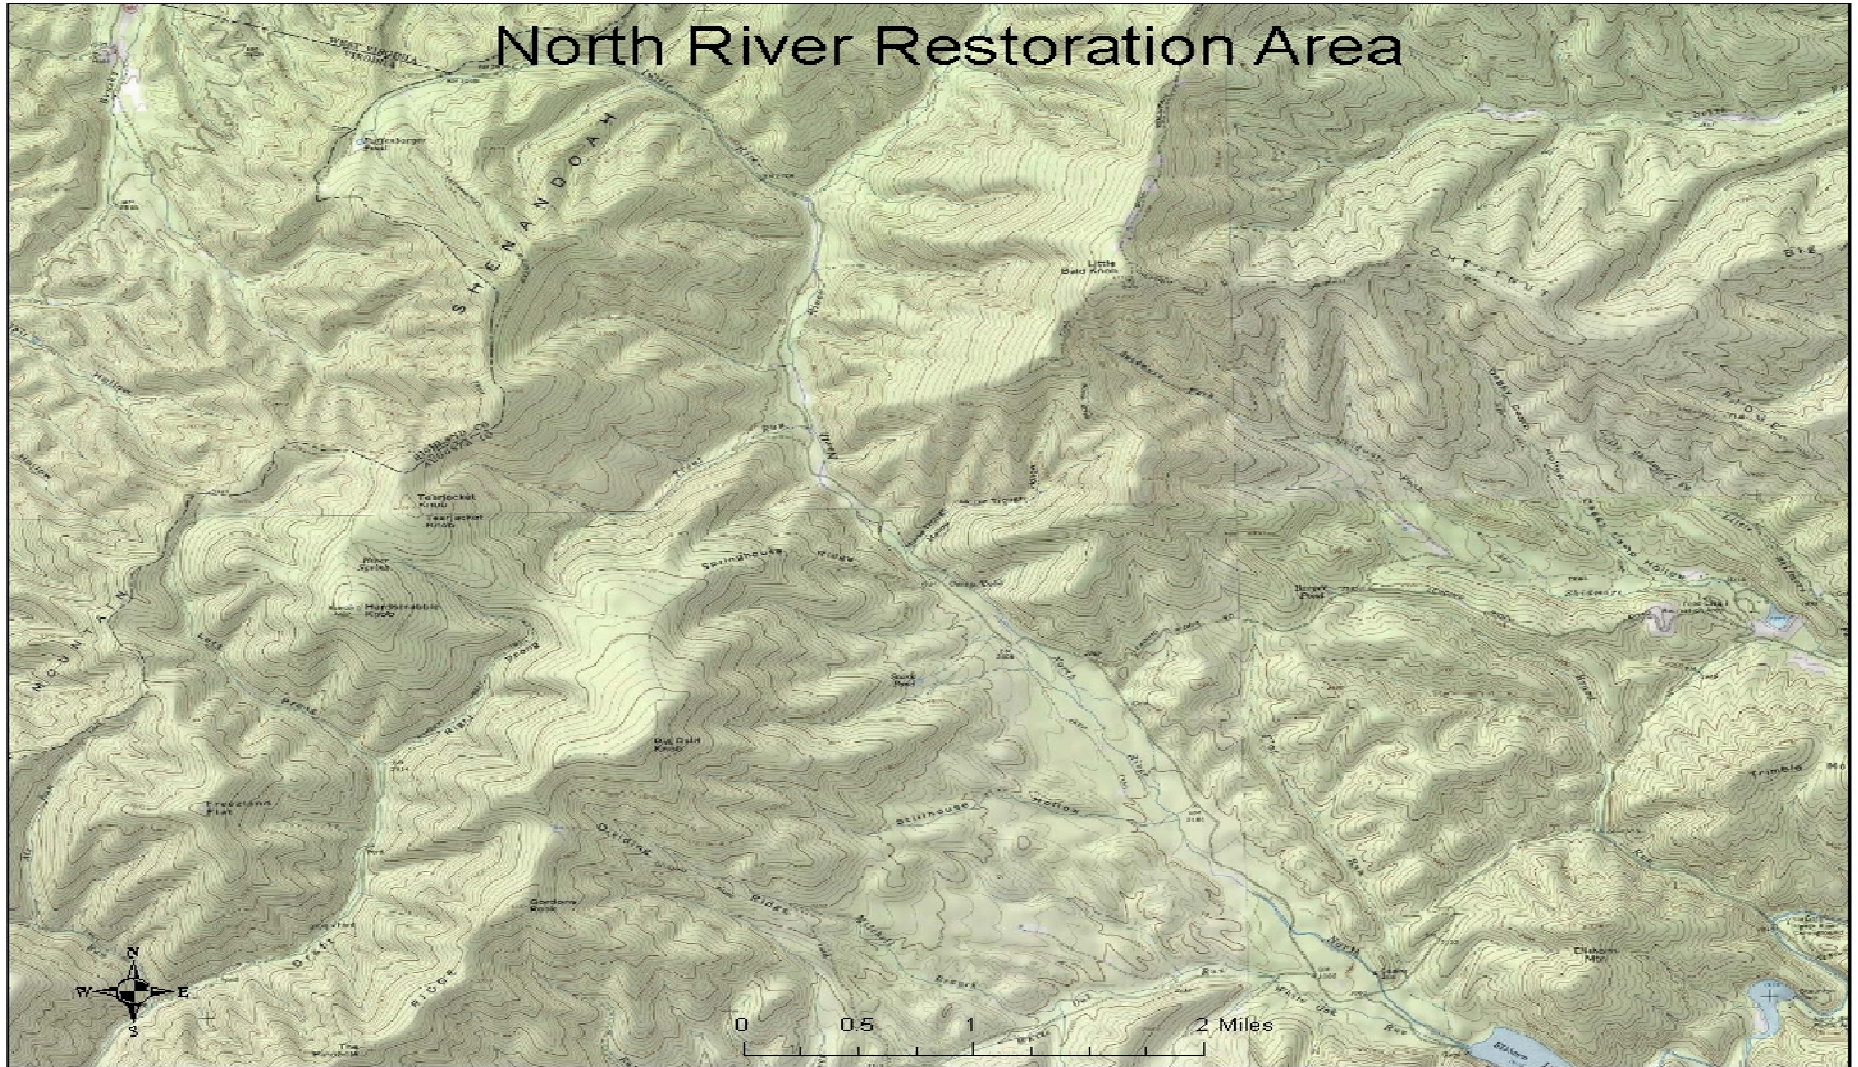
Channel restoration following 1949 flood

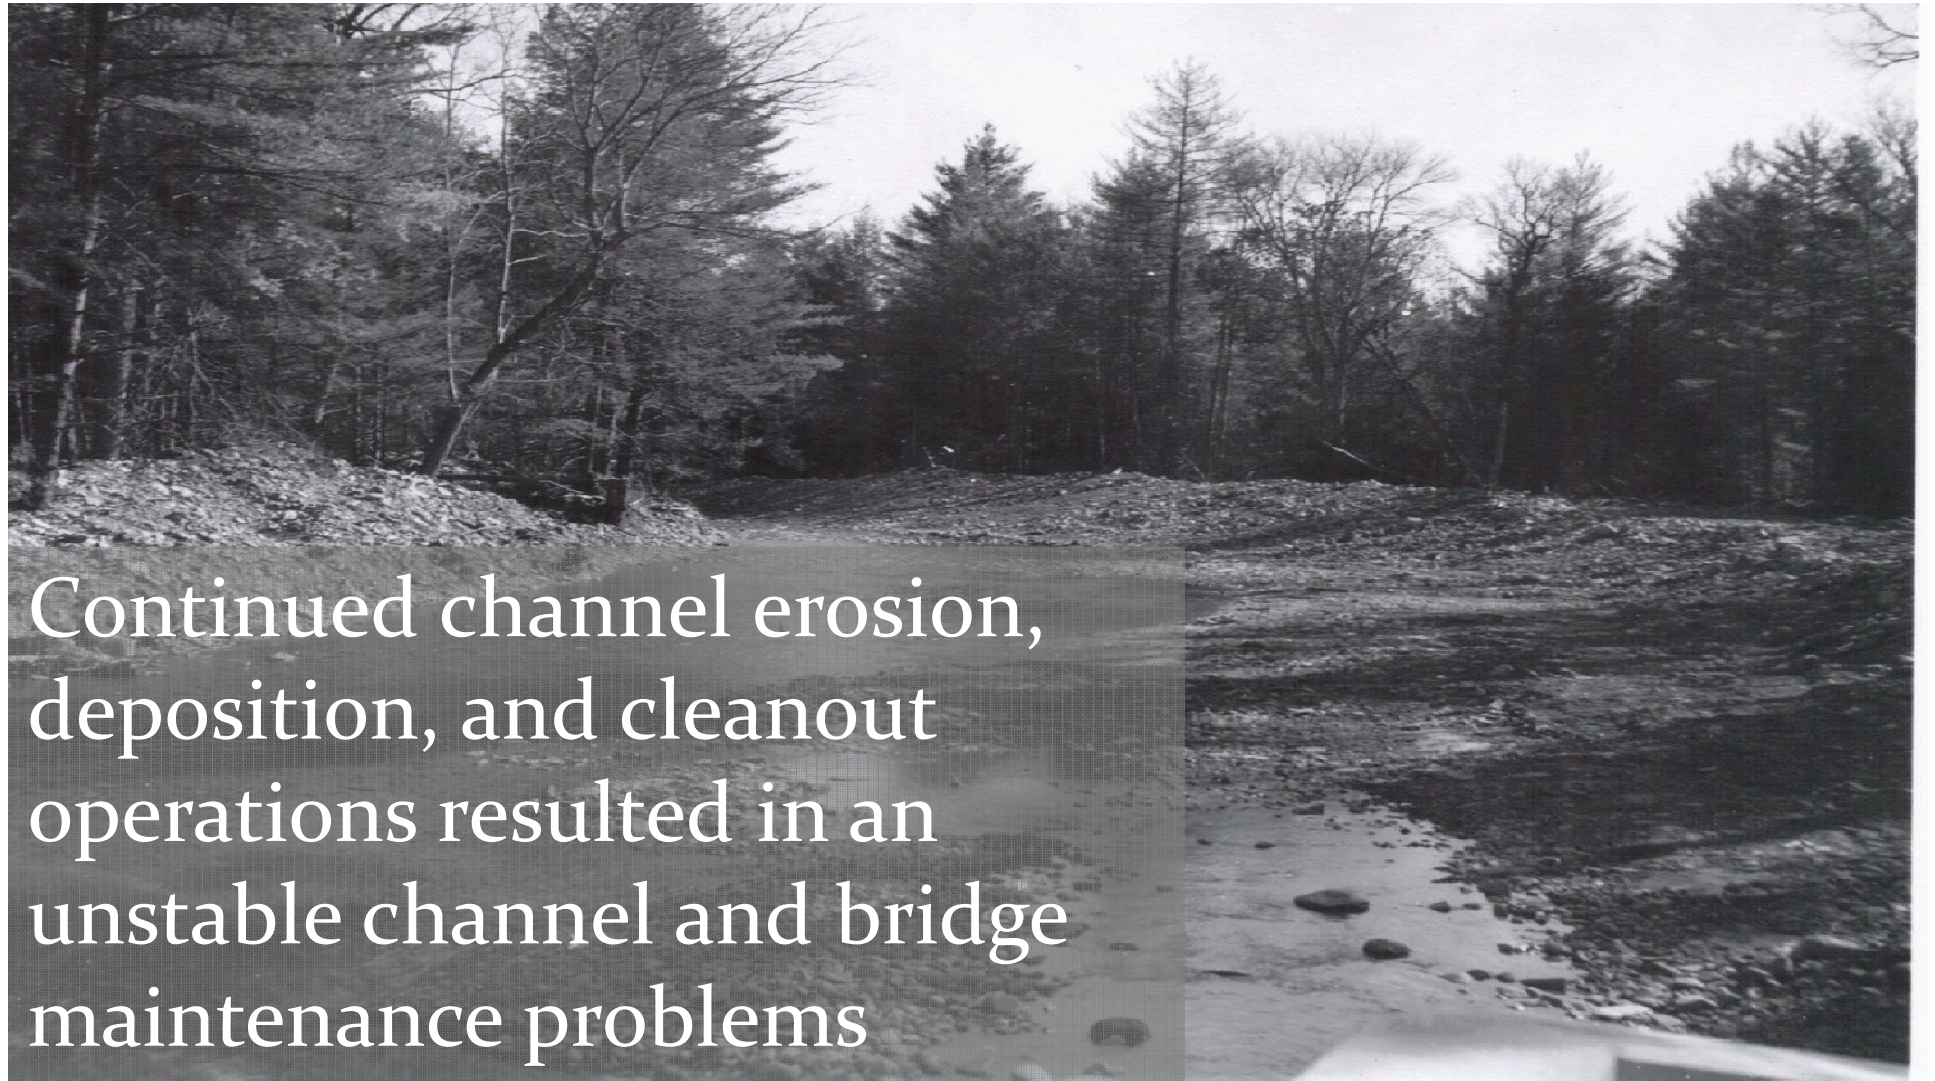
Continued channel erosion, deposition, and cleanout operations resulted in an unstable channel and bridge maintenance problems

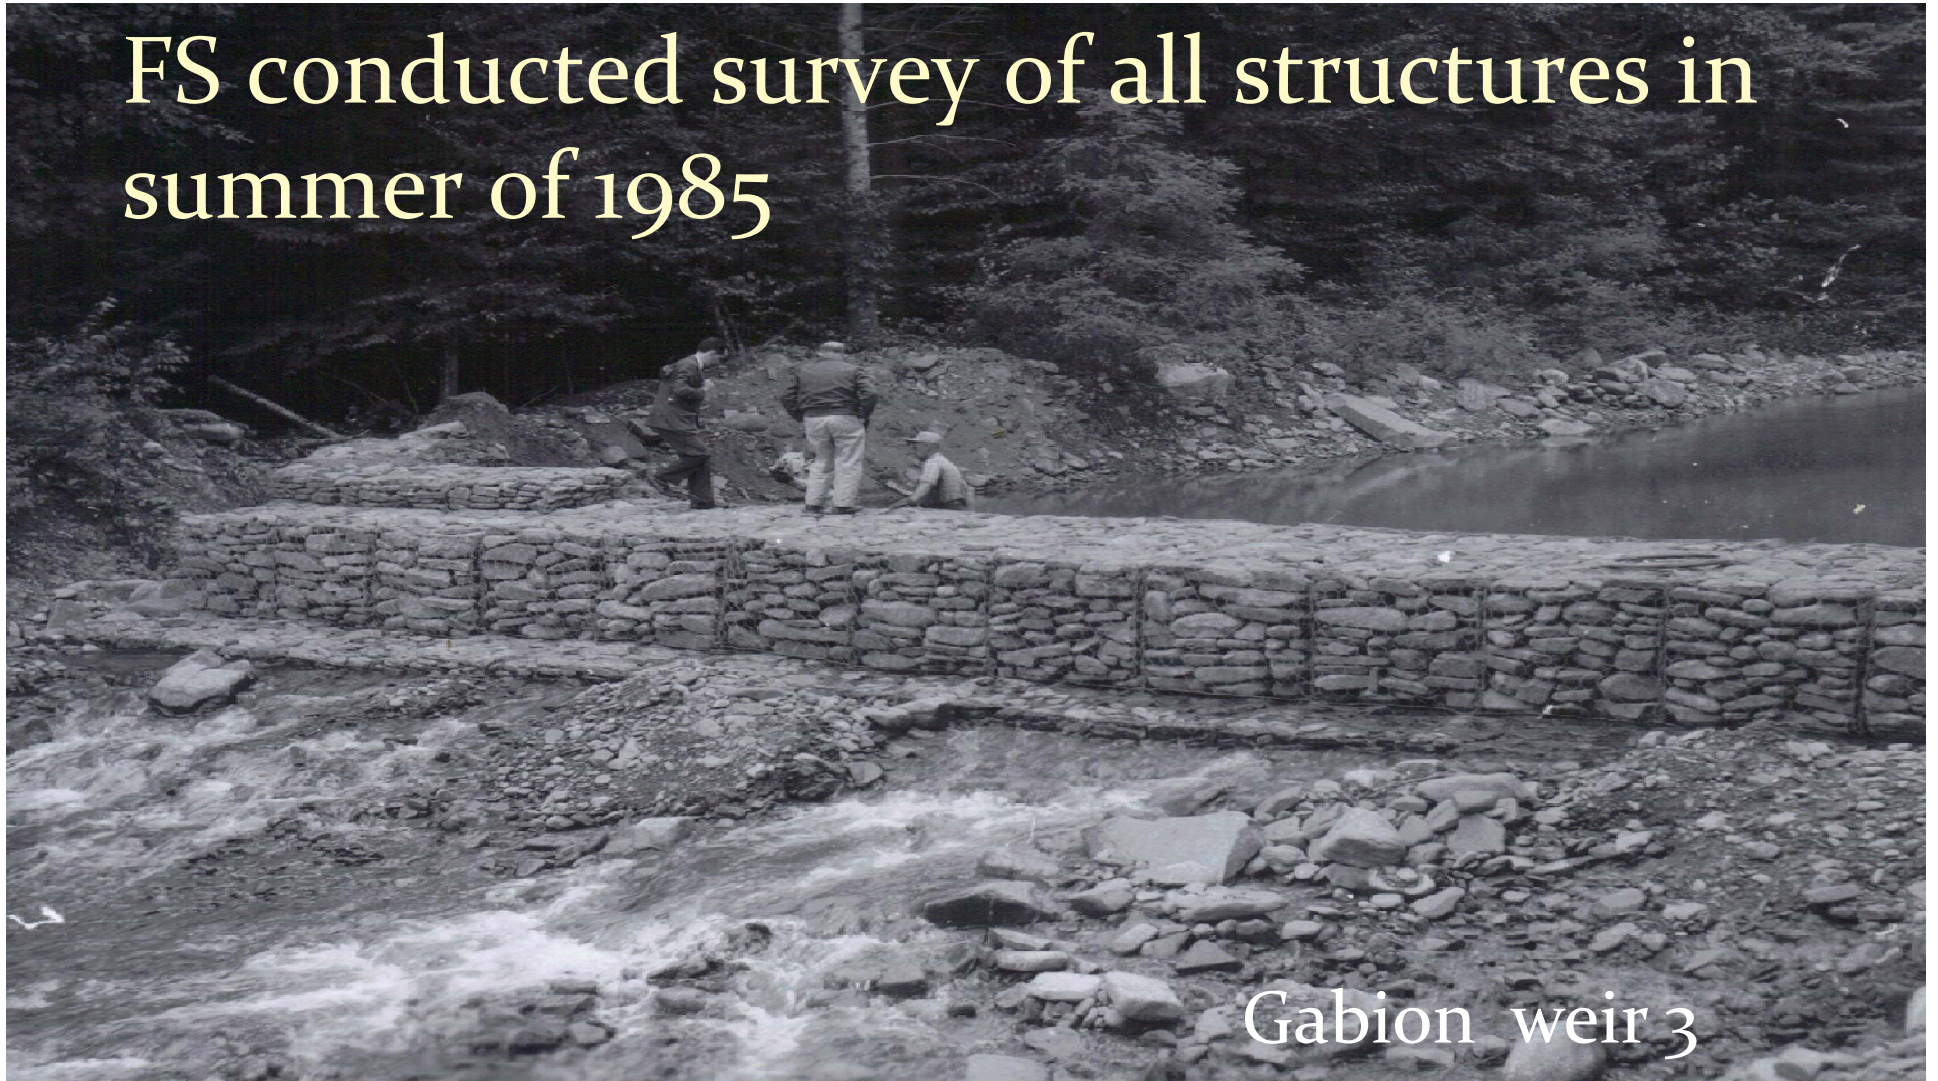
Gabion weir 3

1959-1965:
7 cross-channel weirs
69 walls
17 groins

FS conducted survey of all structures in
summer of 1985

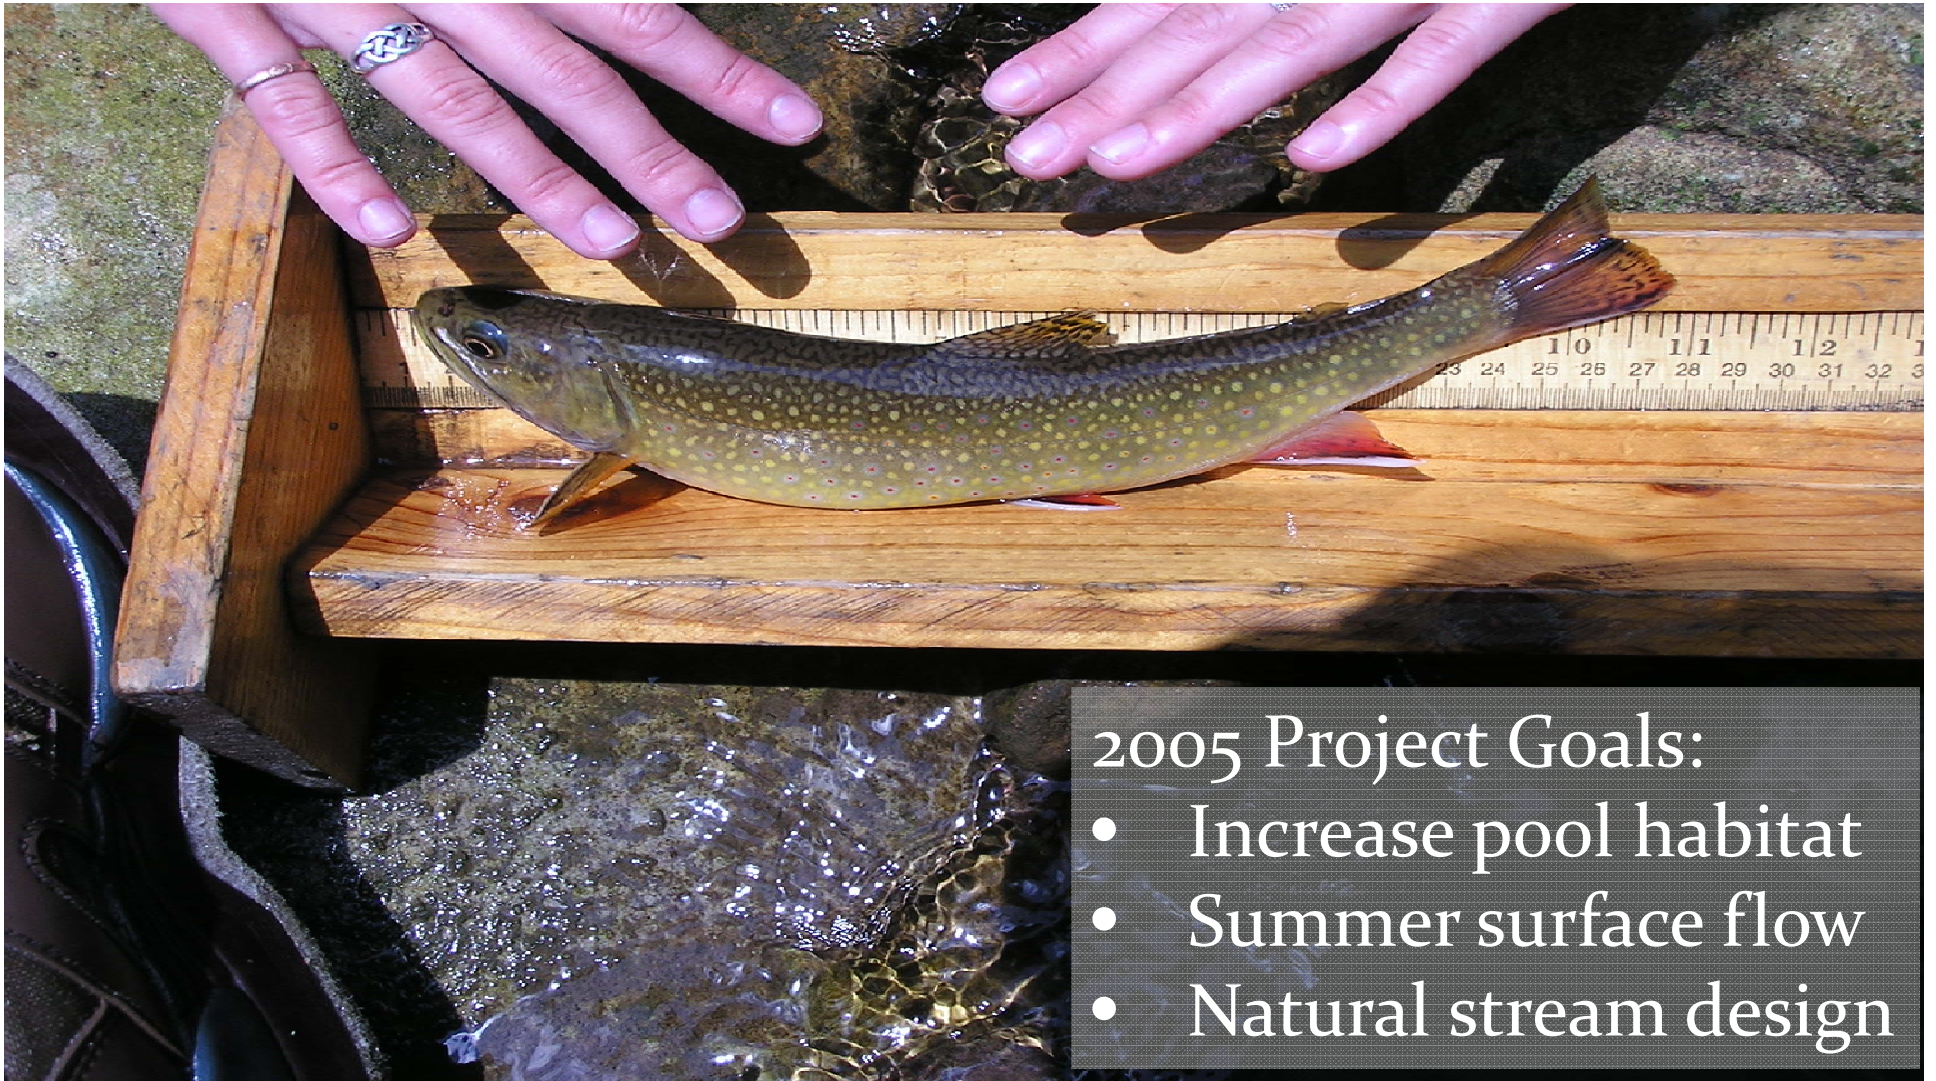
Survey following 1985 Flood:

- Most of structures gone, buried, or had major damage
- Overall impact was general widening (by 16 feet) and deepening (by 1 foot) of the channel transects.
- Lack of channel complexity; large areas with little summer surface flow

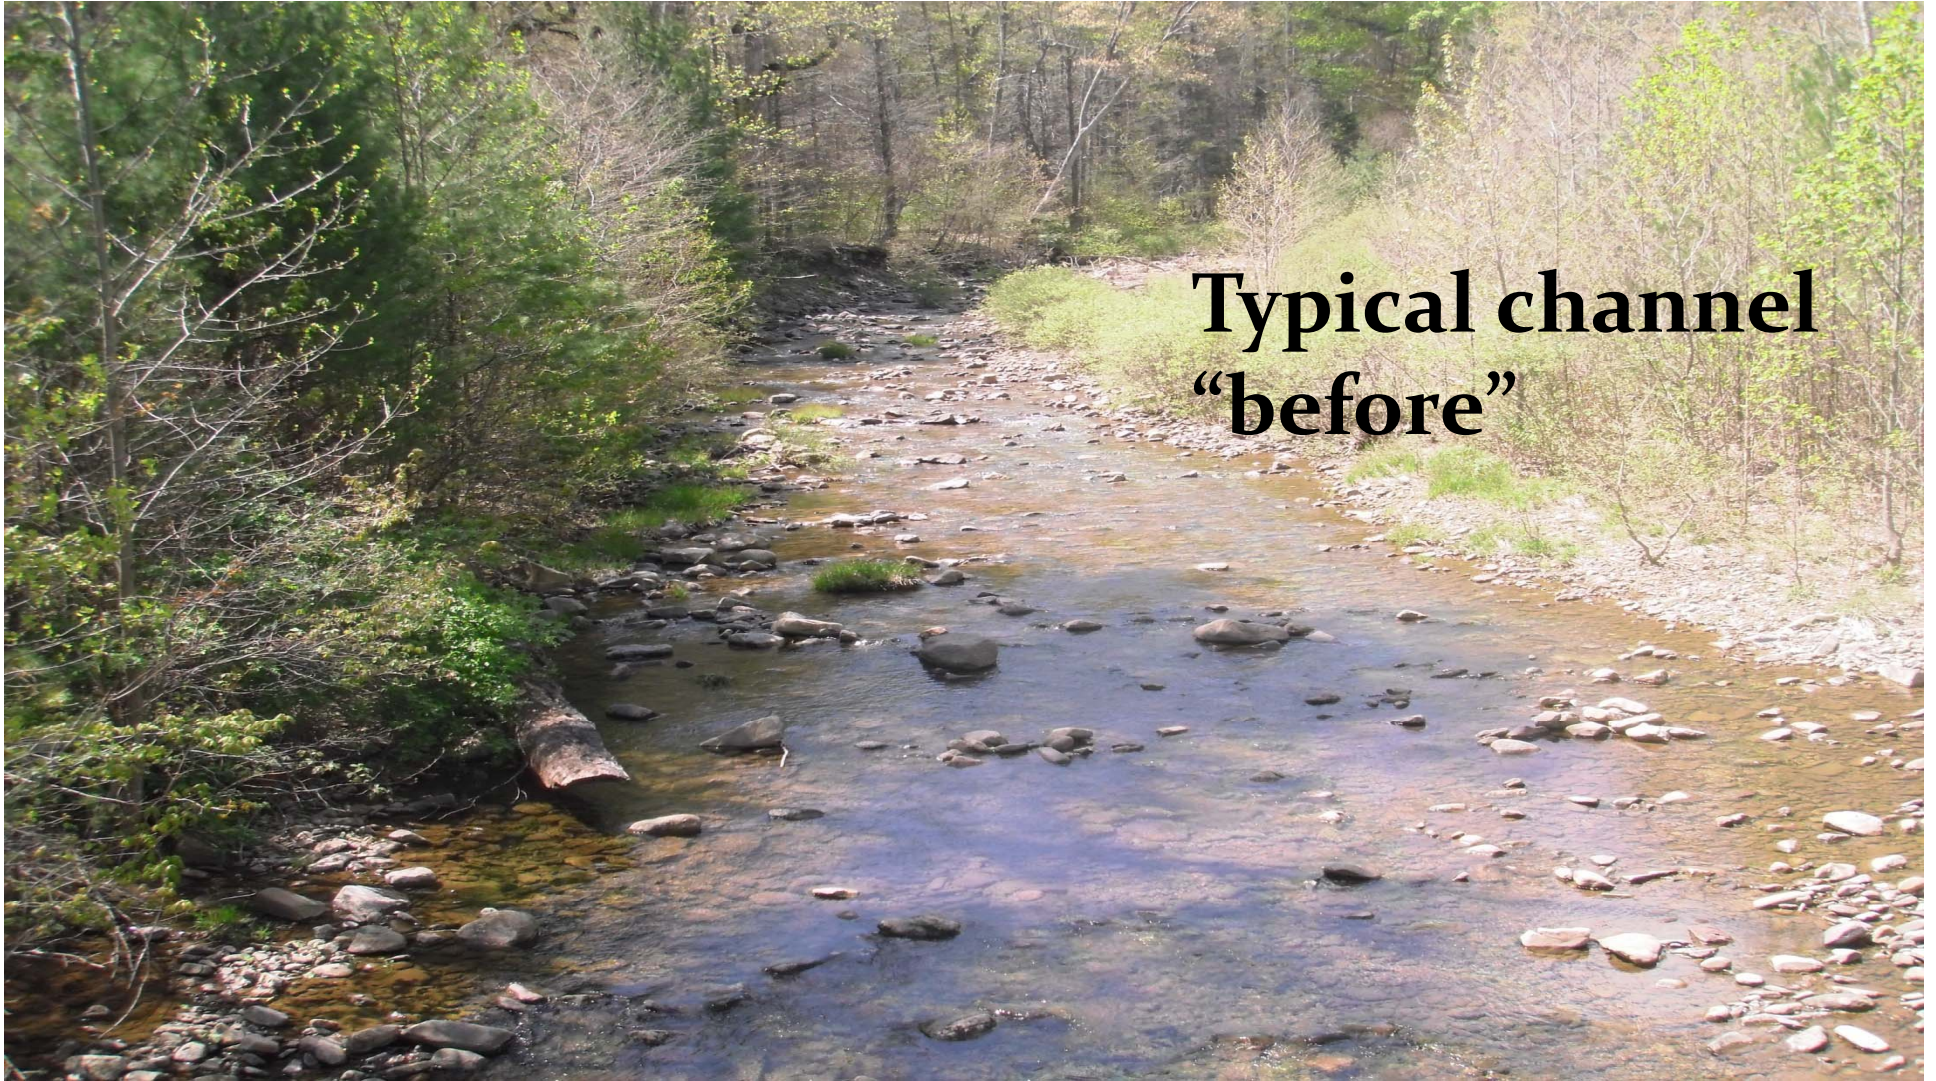
**Typical channel
"before"**

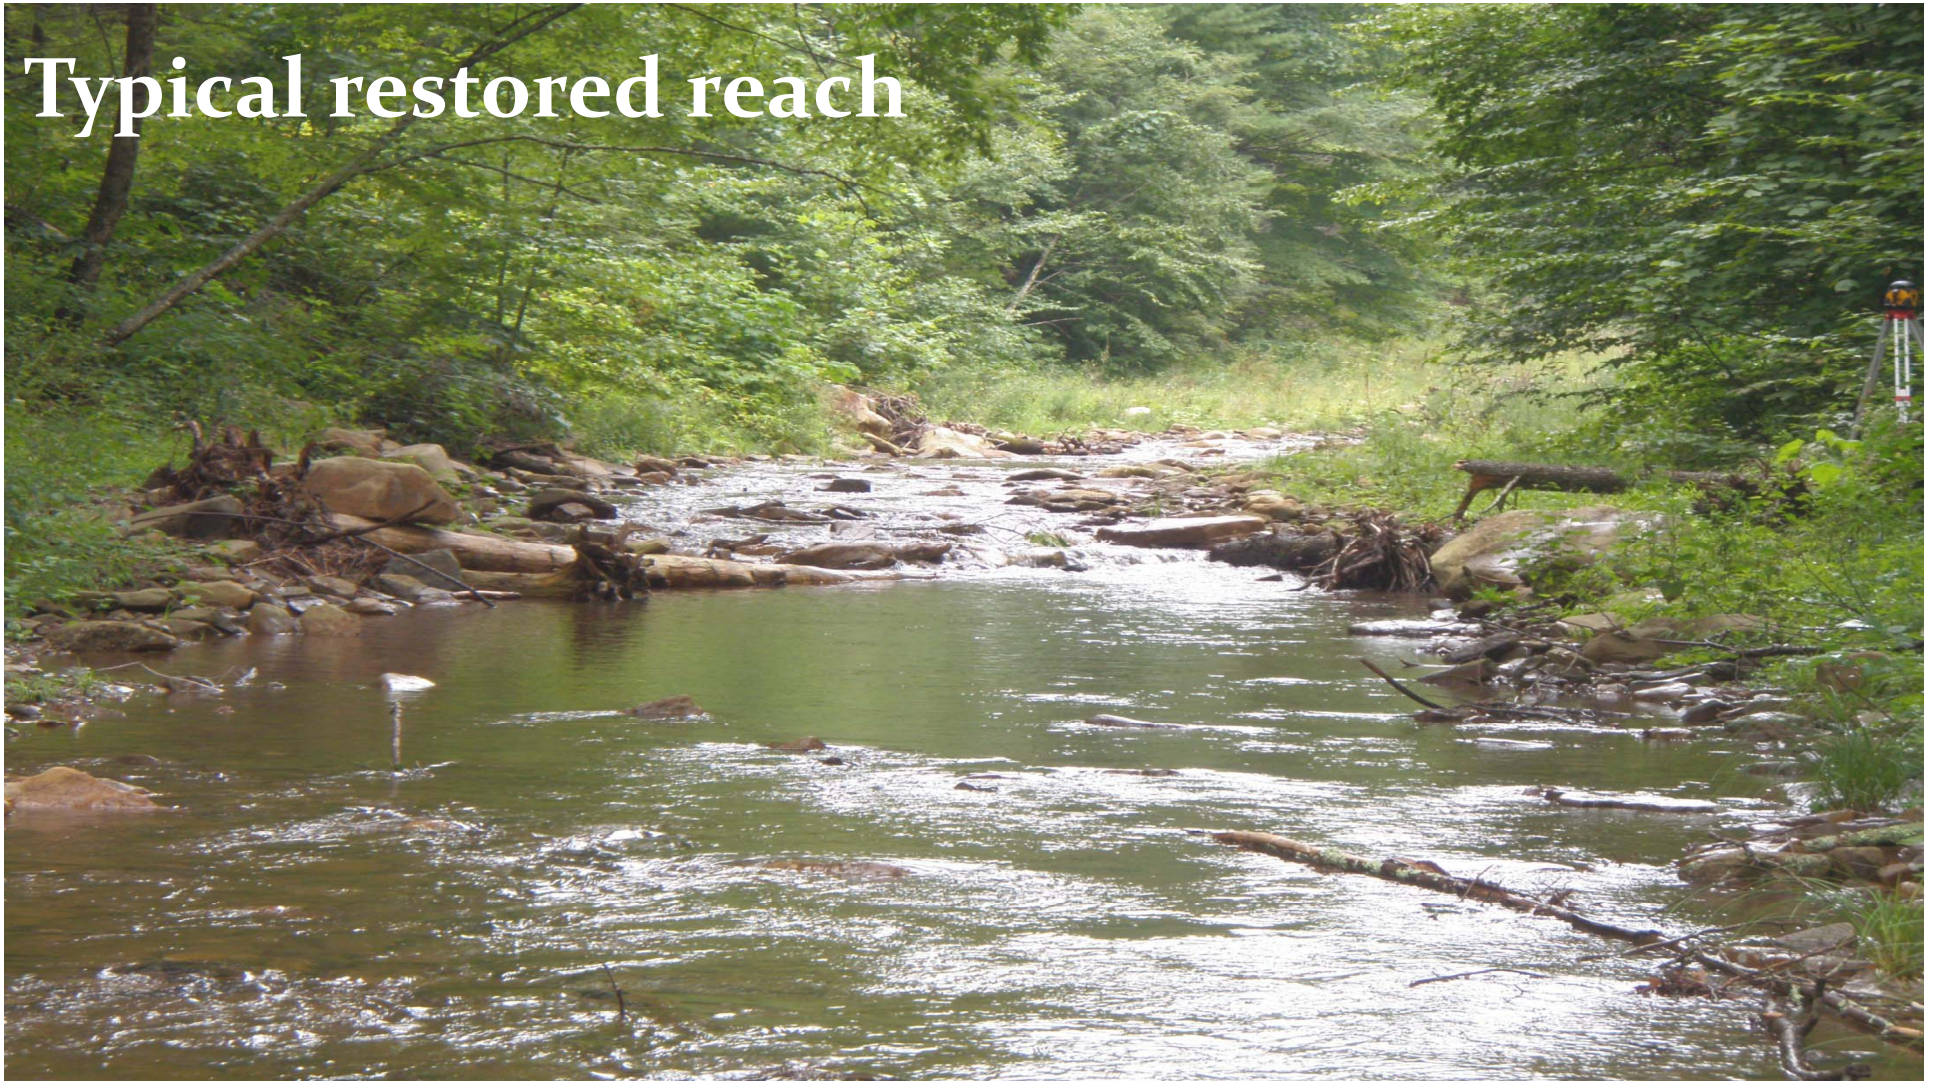
Typical restored reach

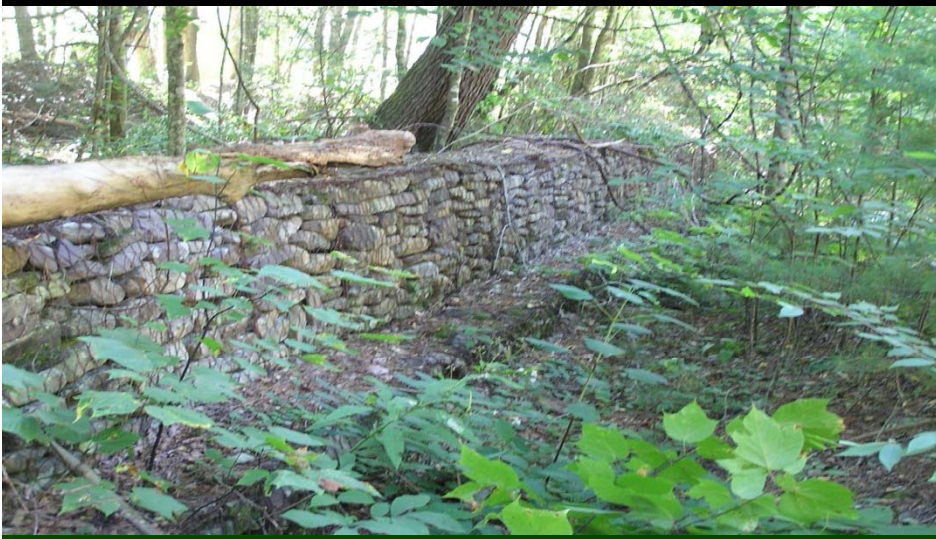
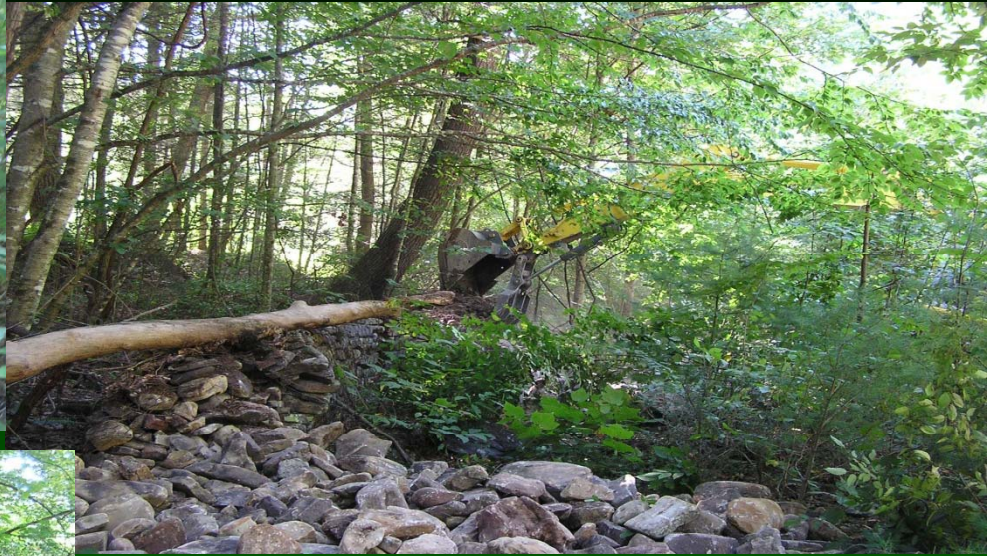
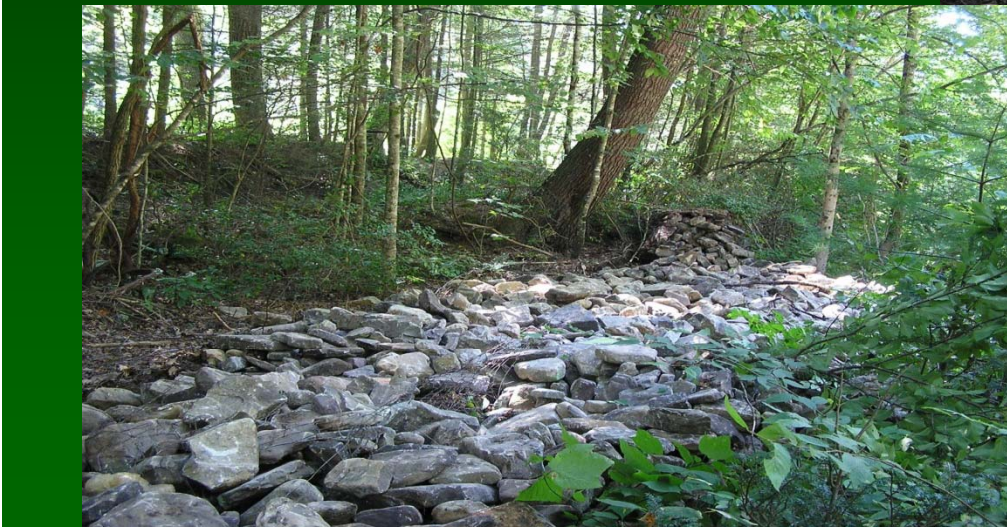
2005 demolition of
gabion walls
blocking the
floodplain

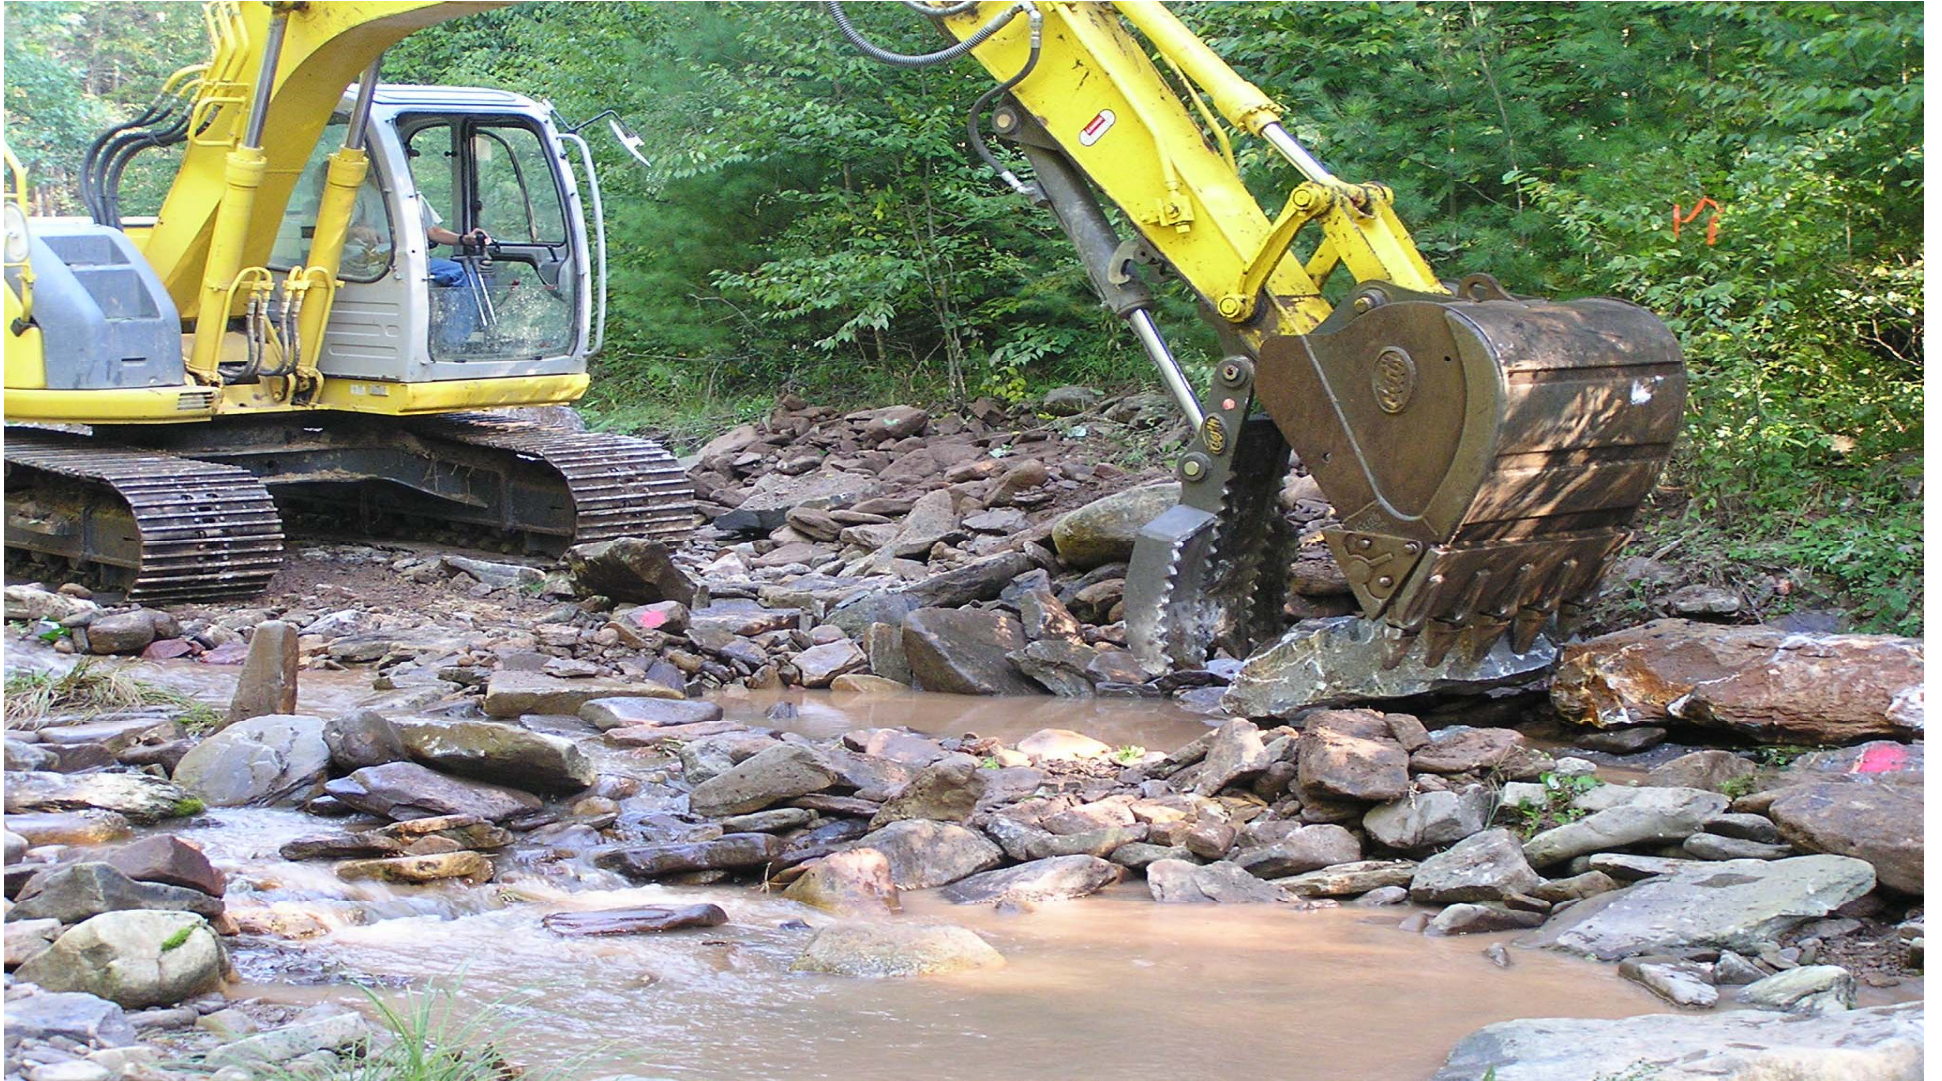
2005 rock vane
construction

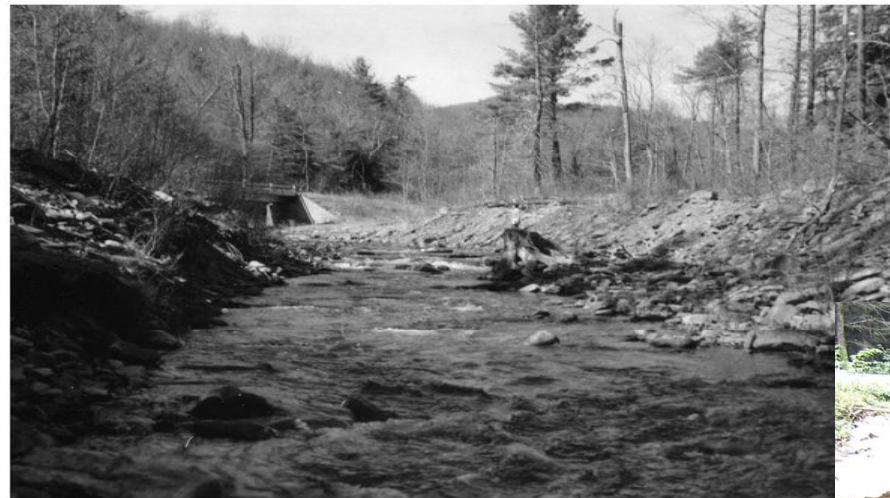
1958 Wall 6
pre-installation

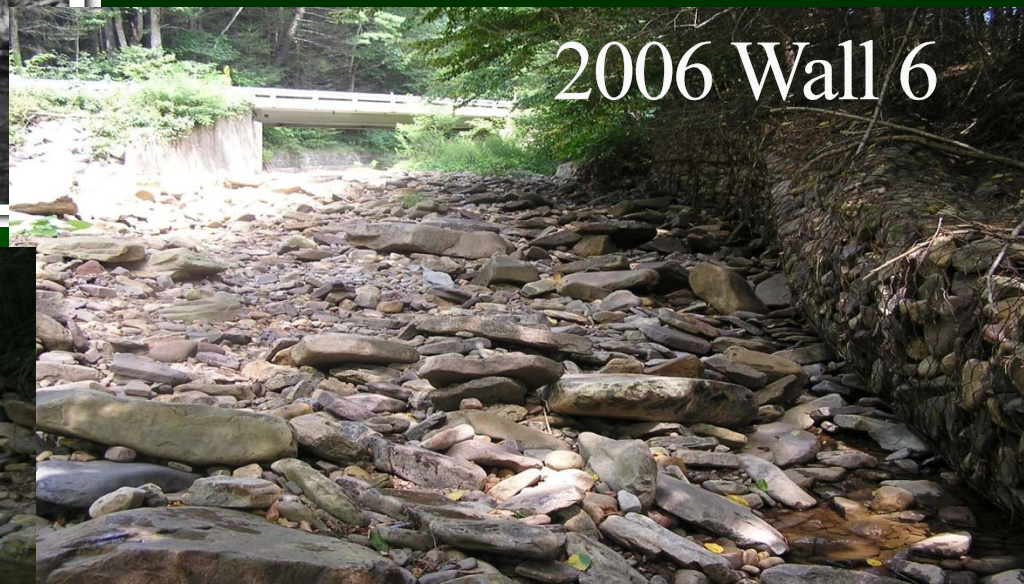
2006 Wall 6

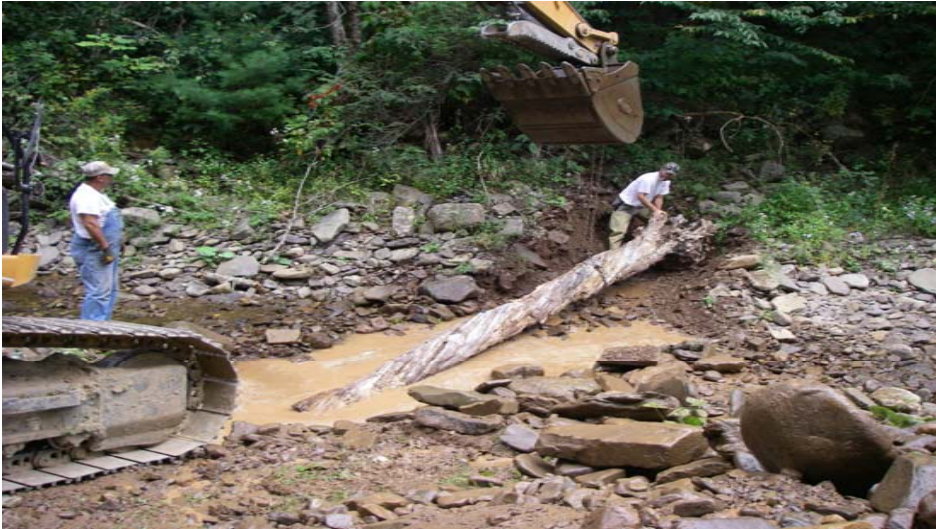
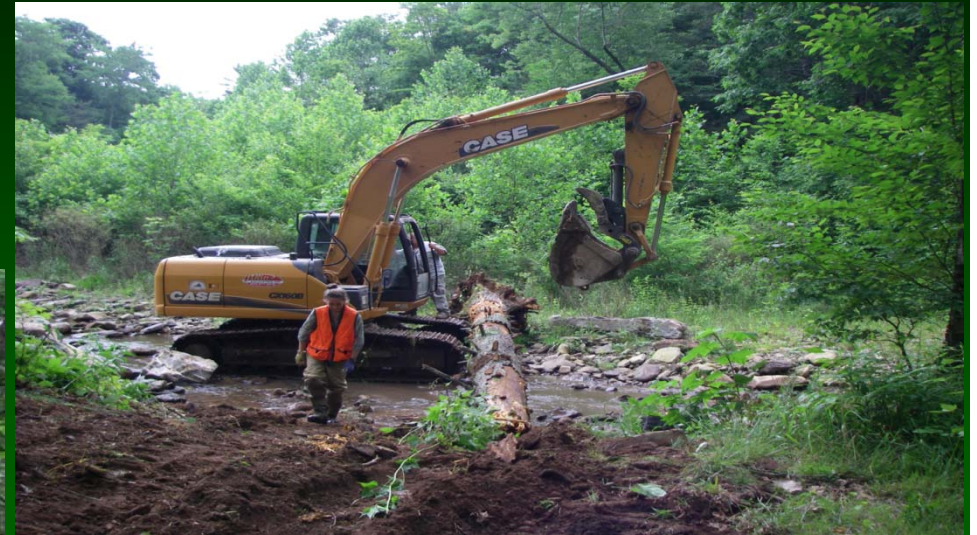
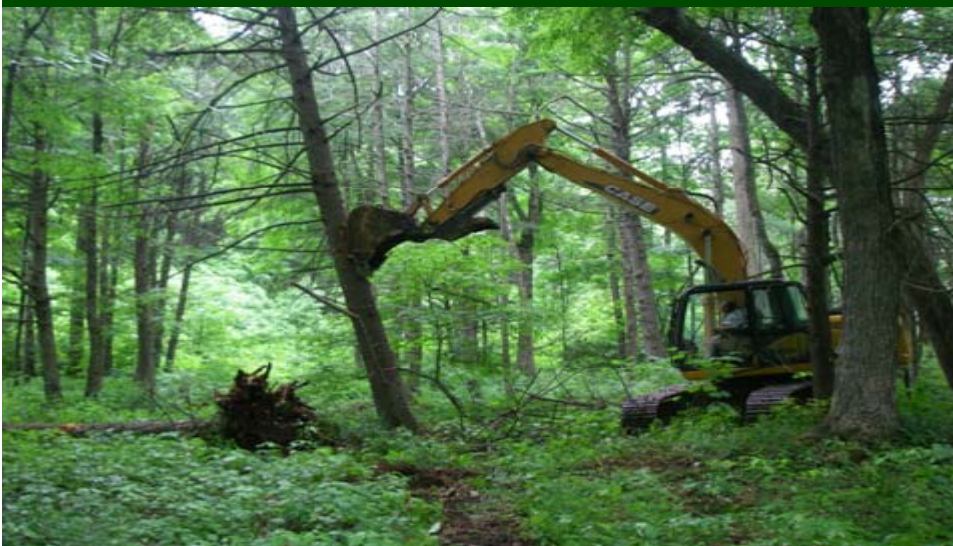
Incorporating wood into structures

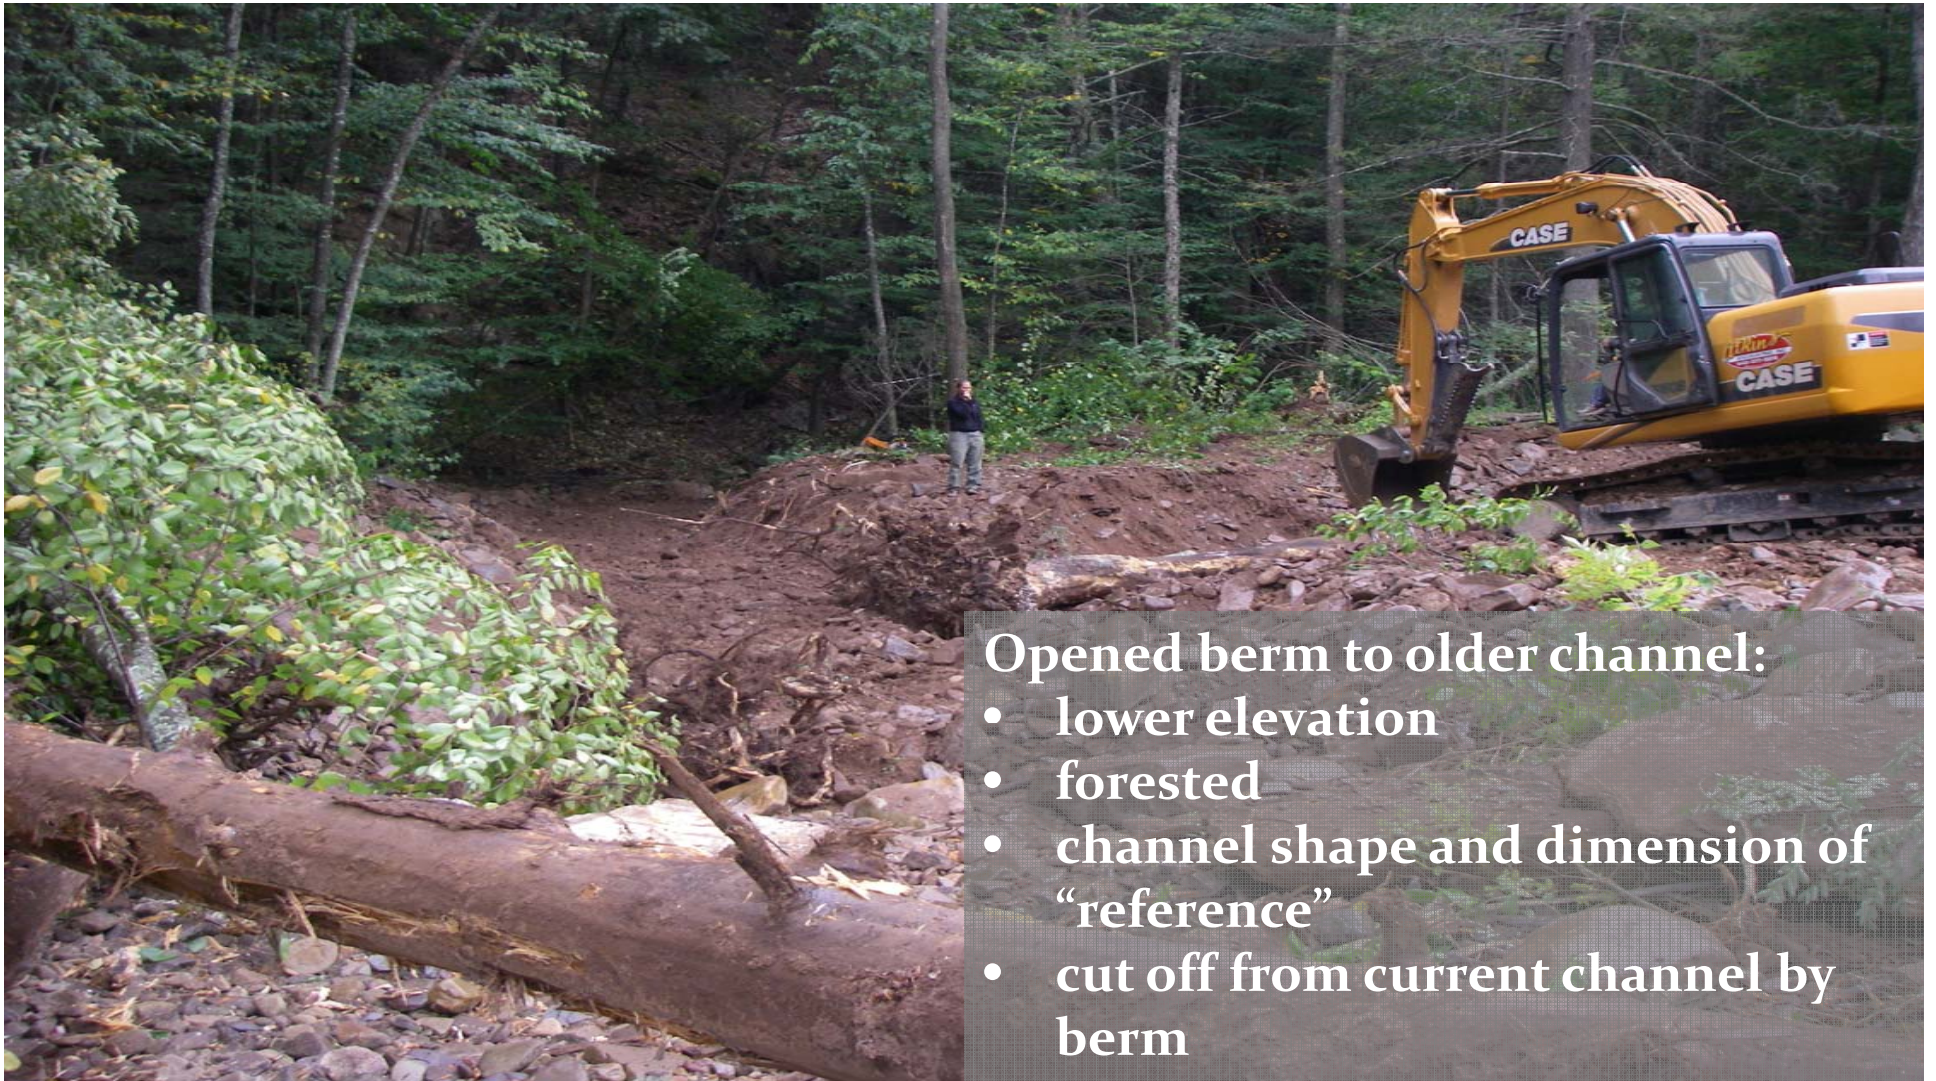
- Opened berm to older channel:
- lower elevation
 - forested
 - channel shape and dimension of “reference”
 - cut off from current channel by berm

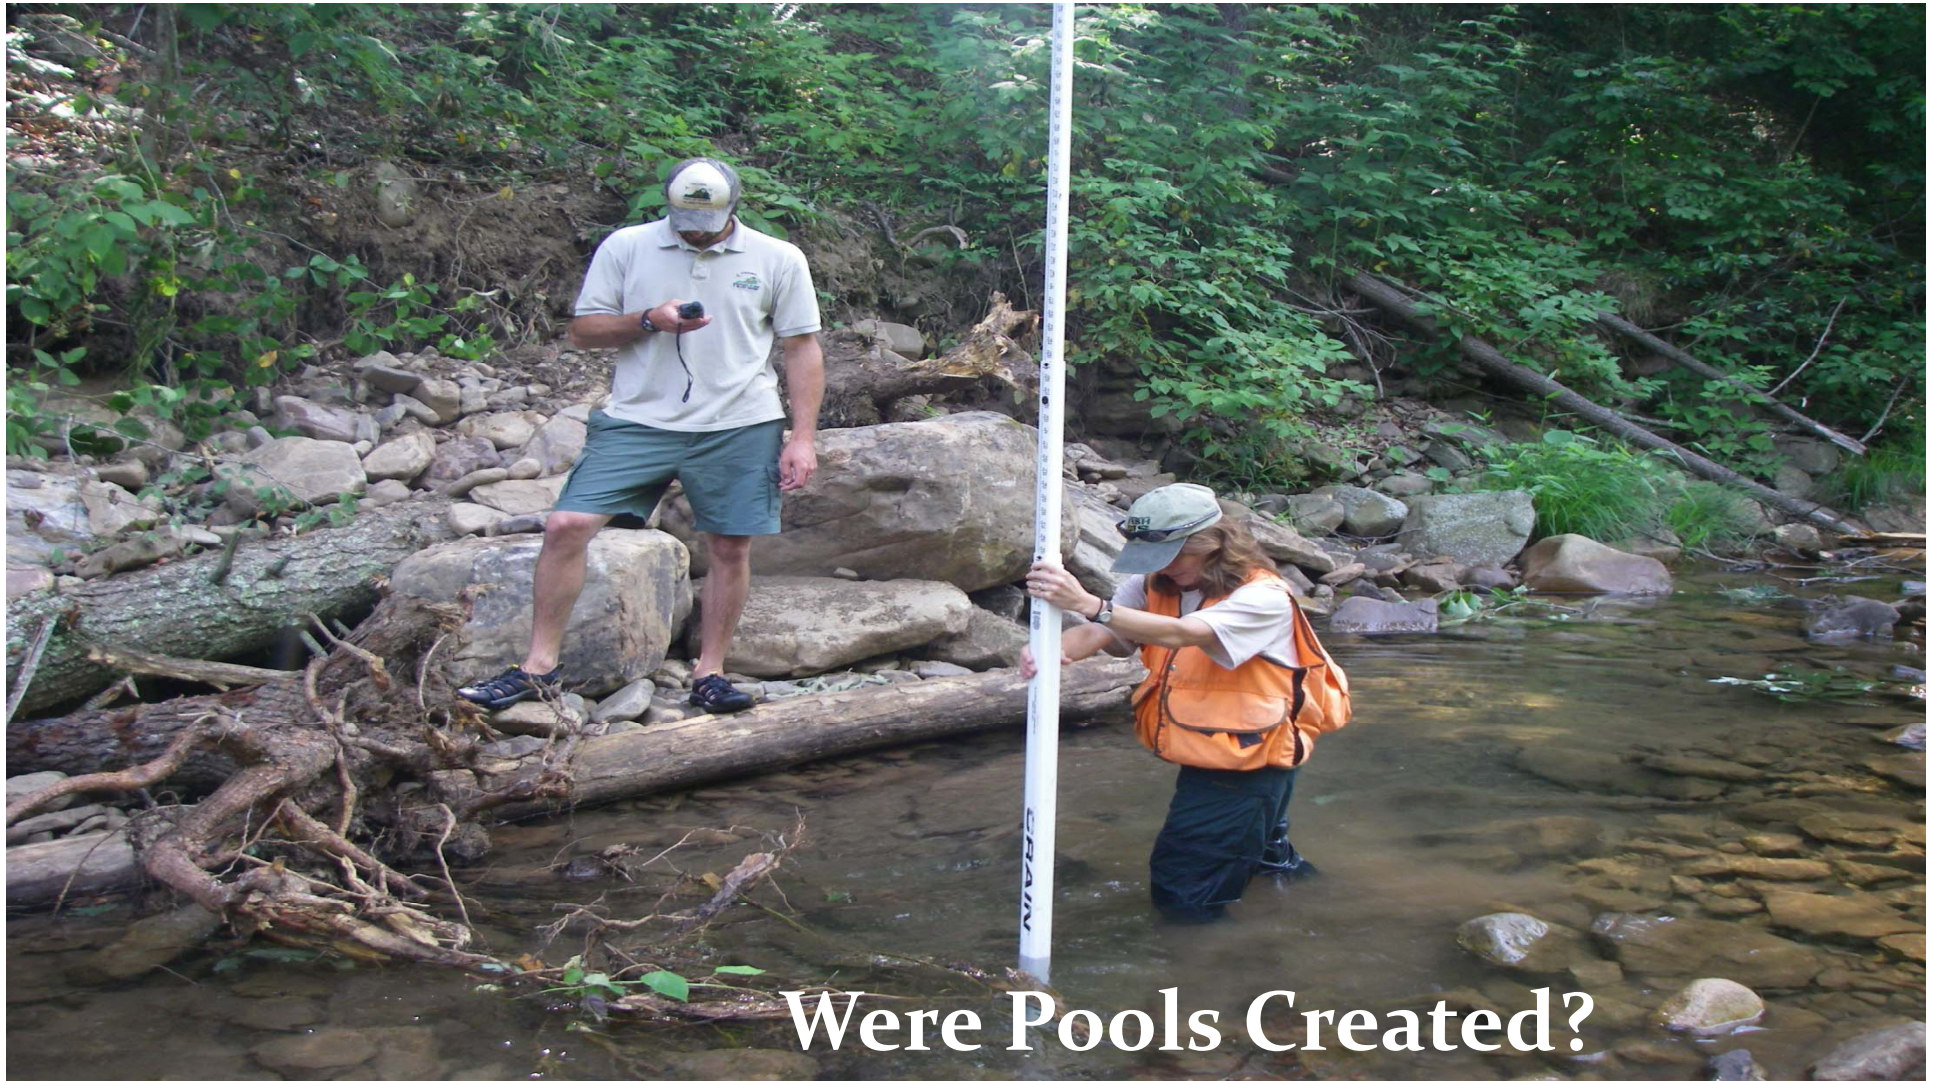
Were Pools Created?

- Mean bankfull pool depth by structure type (j-hook 1.2 m, cross vane 1.2 m)

- Mean bankfull pool width by structure type (j-hooks 14 m, cross-vanes 8 m)
