Aquatic Restoration

George Washington and Jefferson NF

Dawn Kirk
Fisheries Biologist
US Forest Service

Restoration Project Case Studies

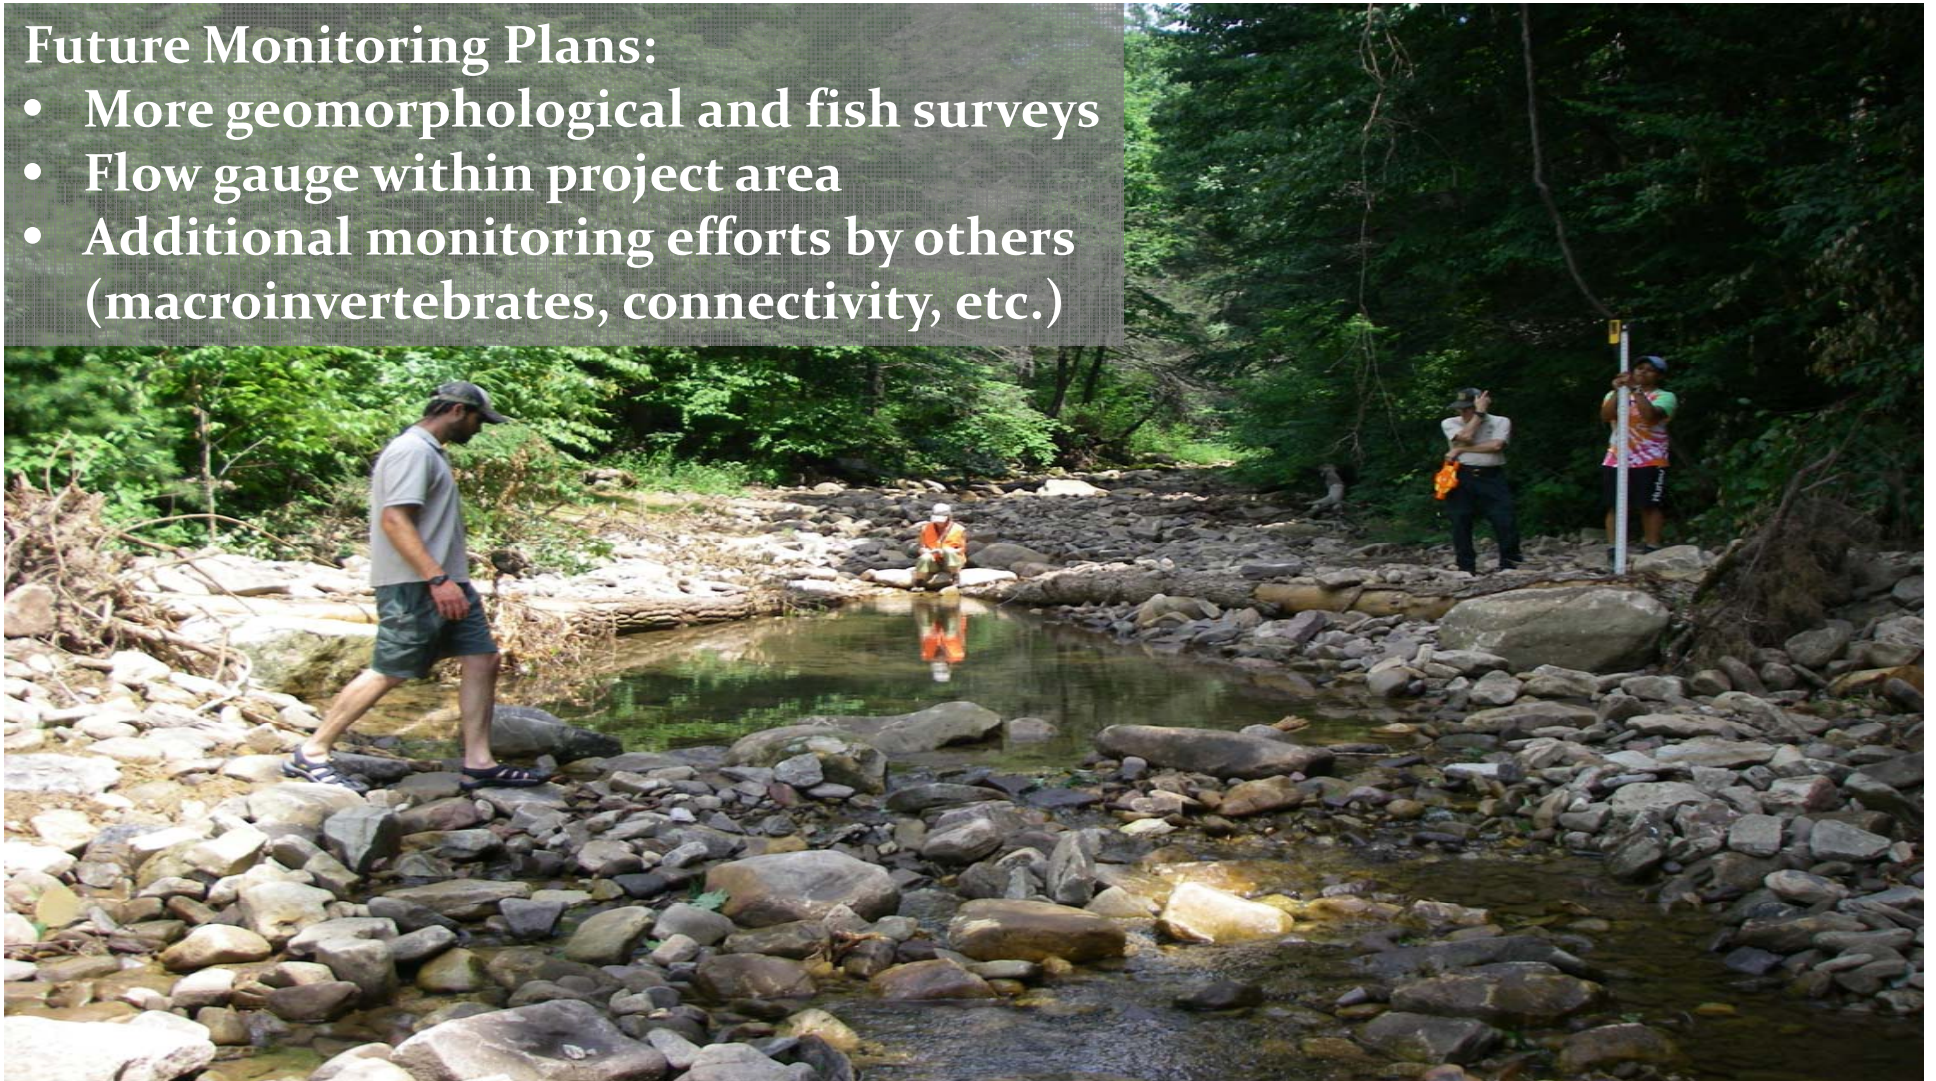
- Relocated 3 road sections out of floodplain
- Eliminated 2 crossings
- Installed 2 bottomless arches

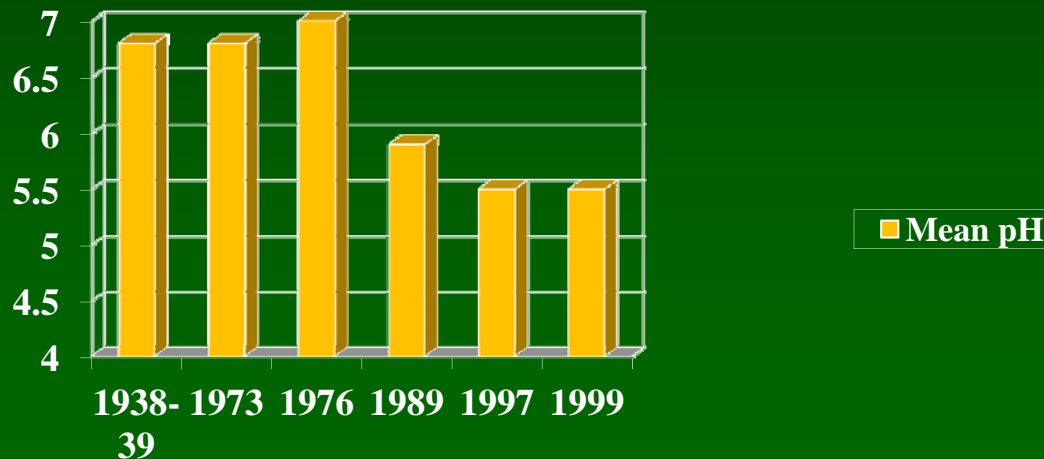
- Ave rainfall pH is 4.3
- Headwater streams acidifying

St. Marys River Historic and Recent pH Means

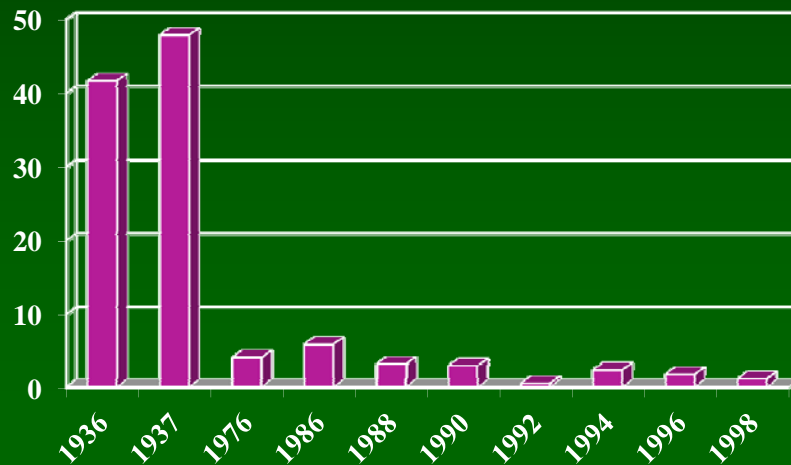
**St. Marys River
Percent Mayfly Abundance**

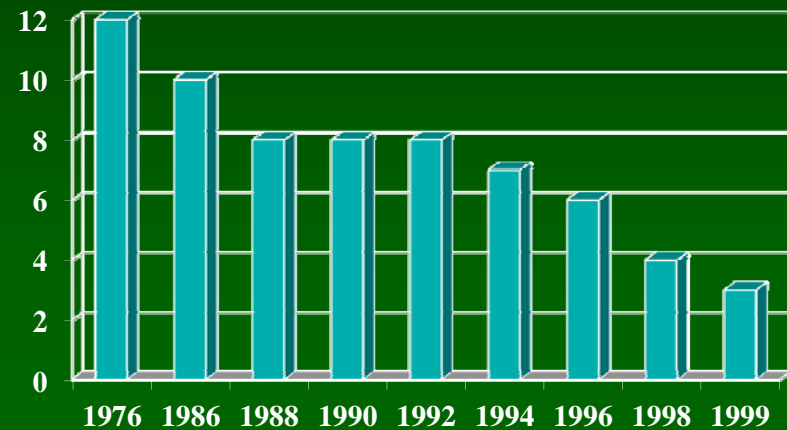
**St. Marys River
Number of Fish Species**

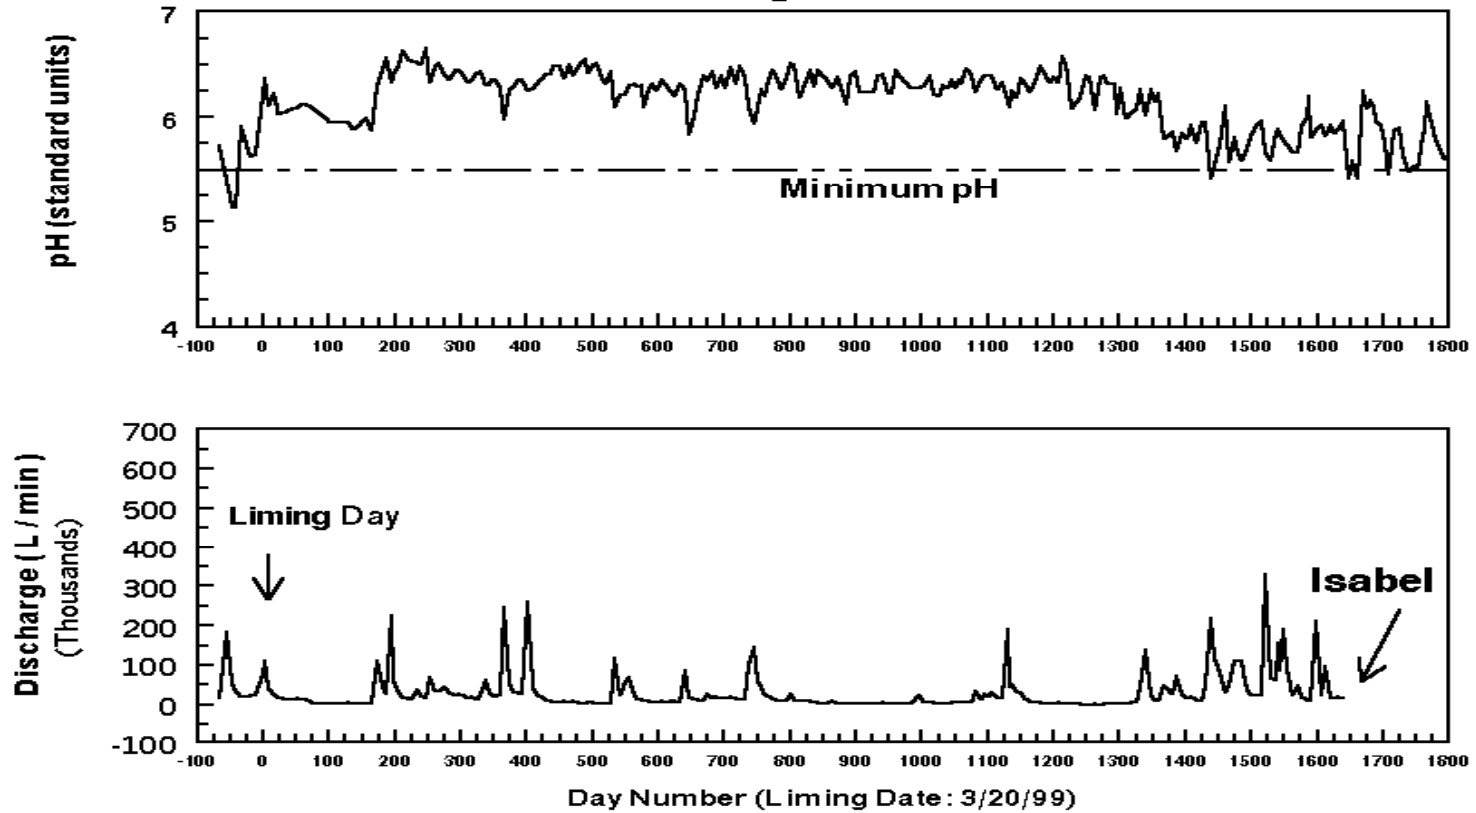
Figure 2

St. Marys River pH and Flow

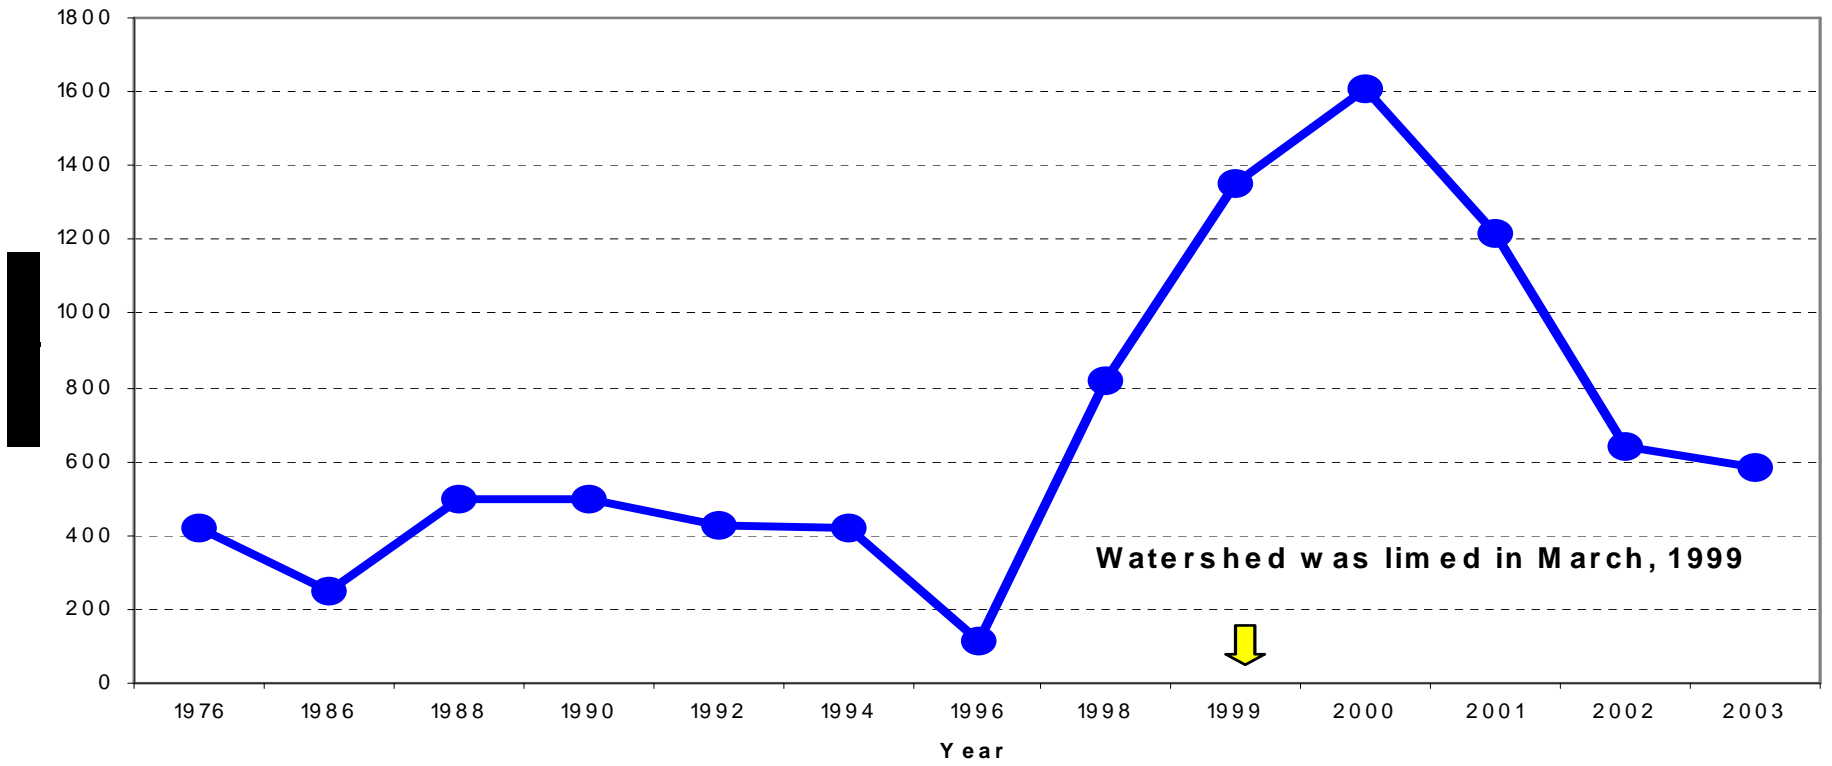
St. Marys Brook Trout Density

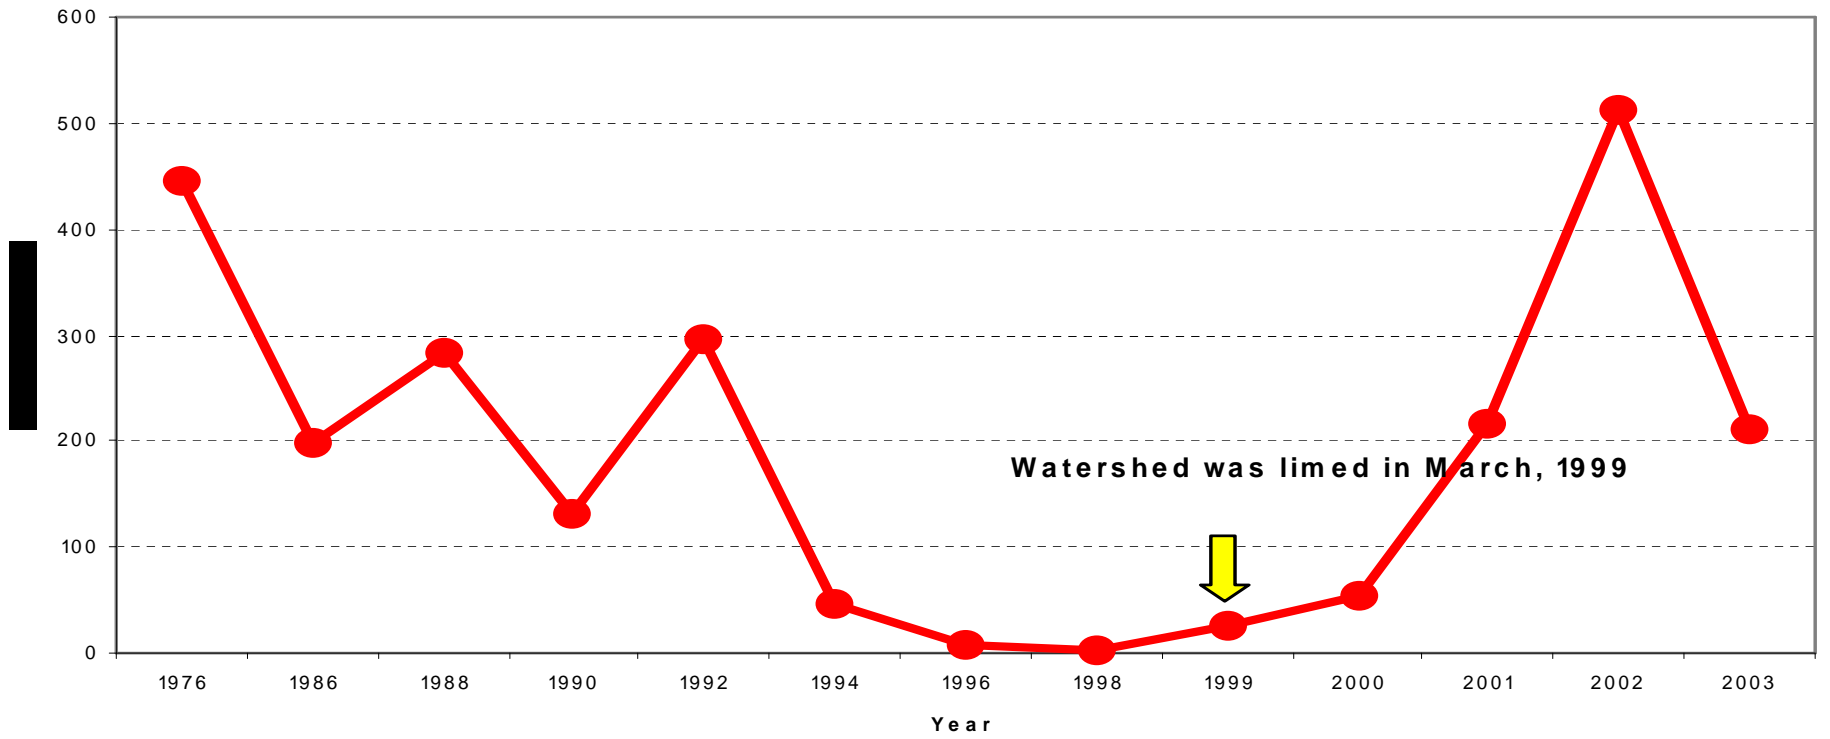
St. Marys Blacknose Dace Density

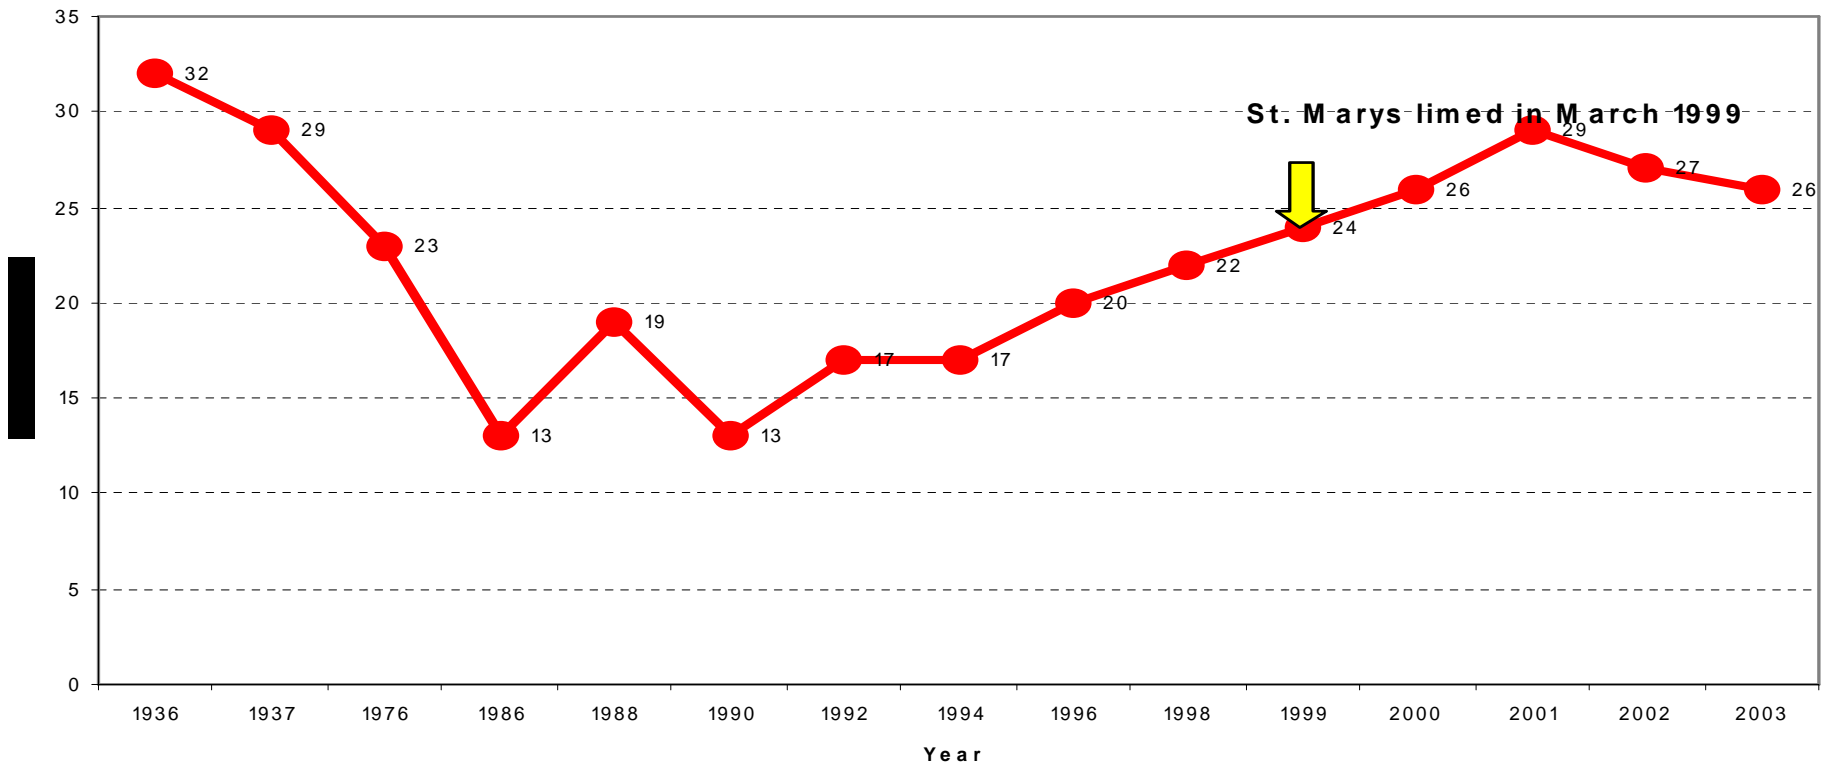
St. Marys Invertebrate Taxa Richness

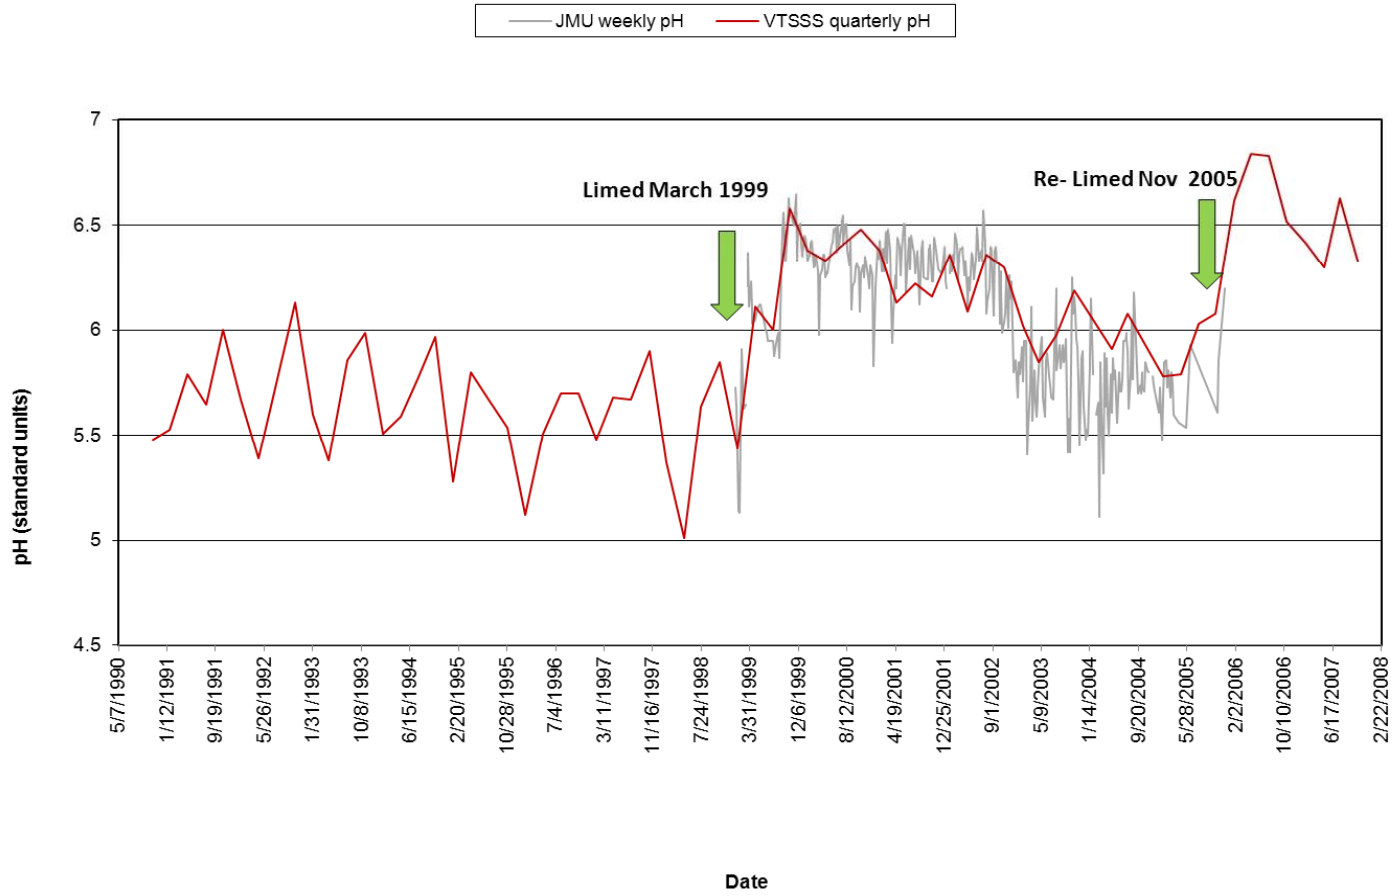
St. Mary's pH 1990 to 2008

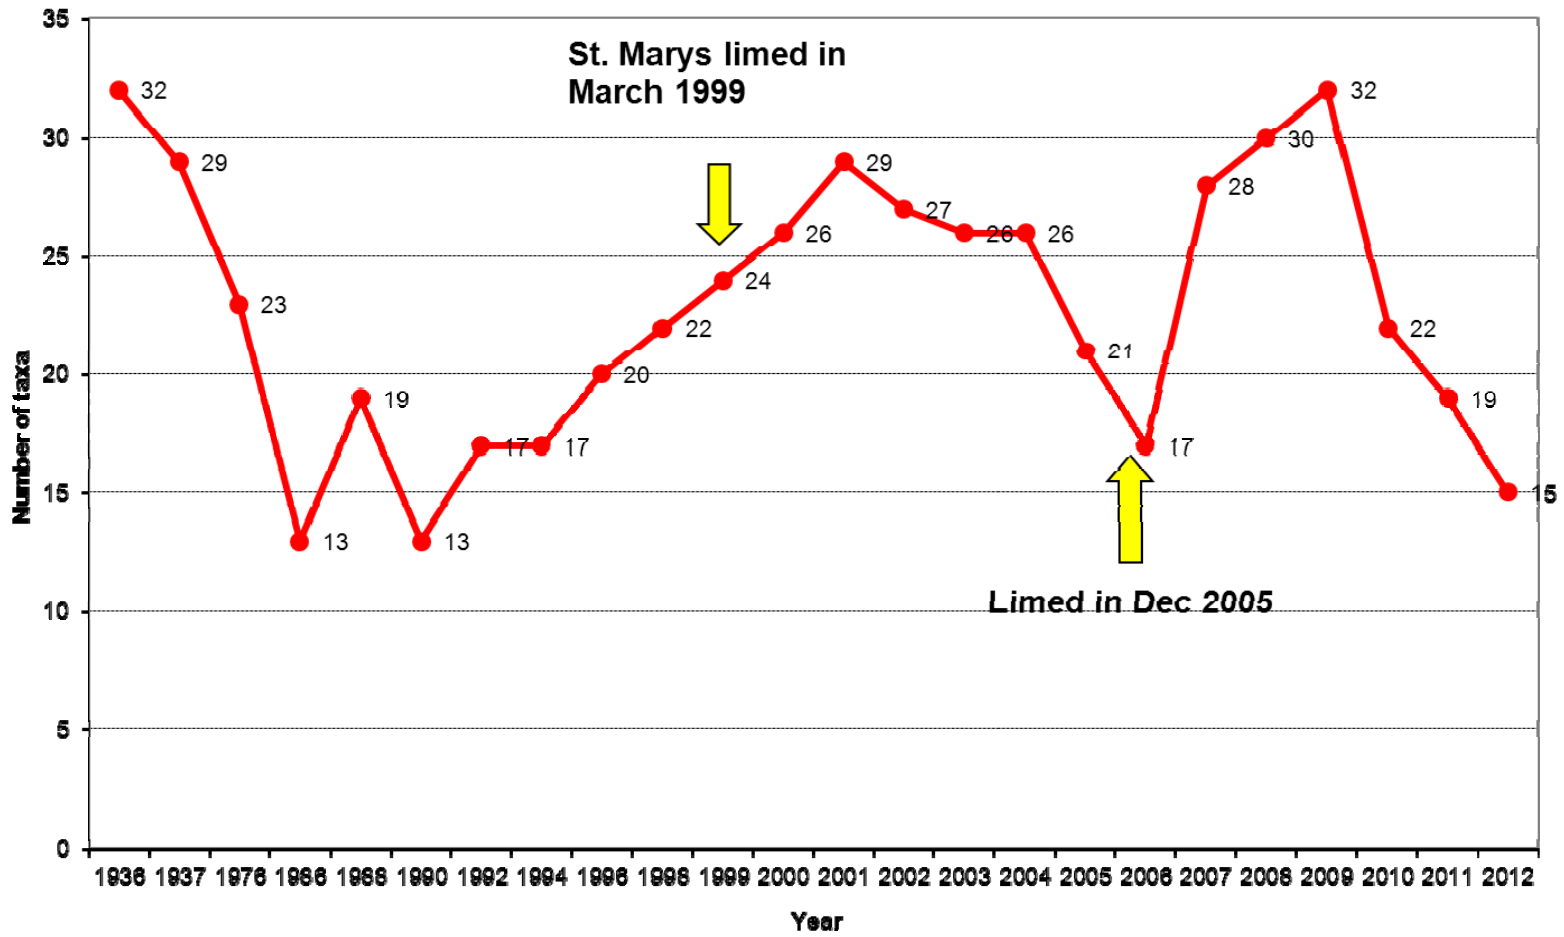
St. Marys Invertebrate Taxa Richness

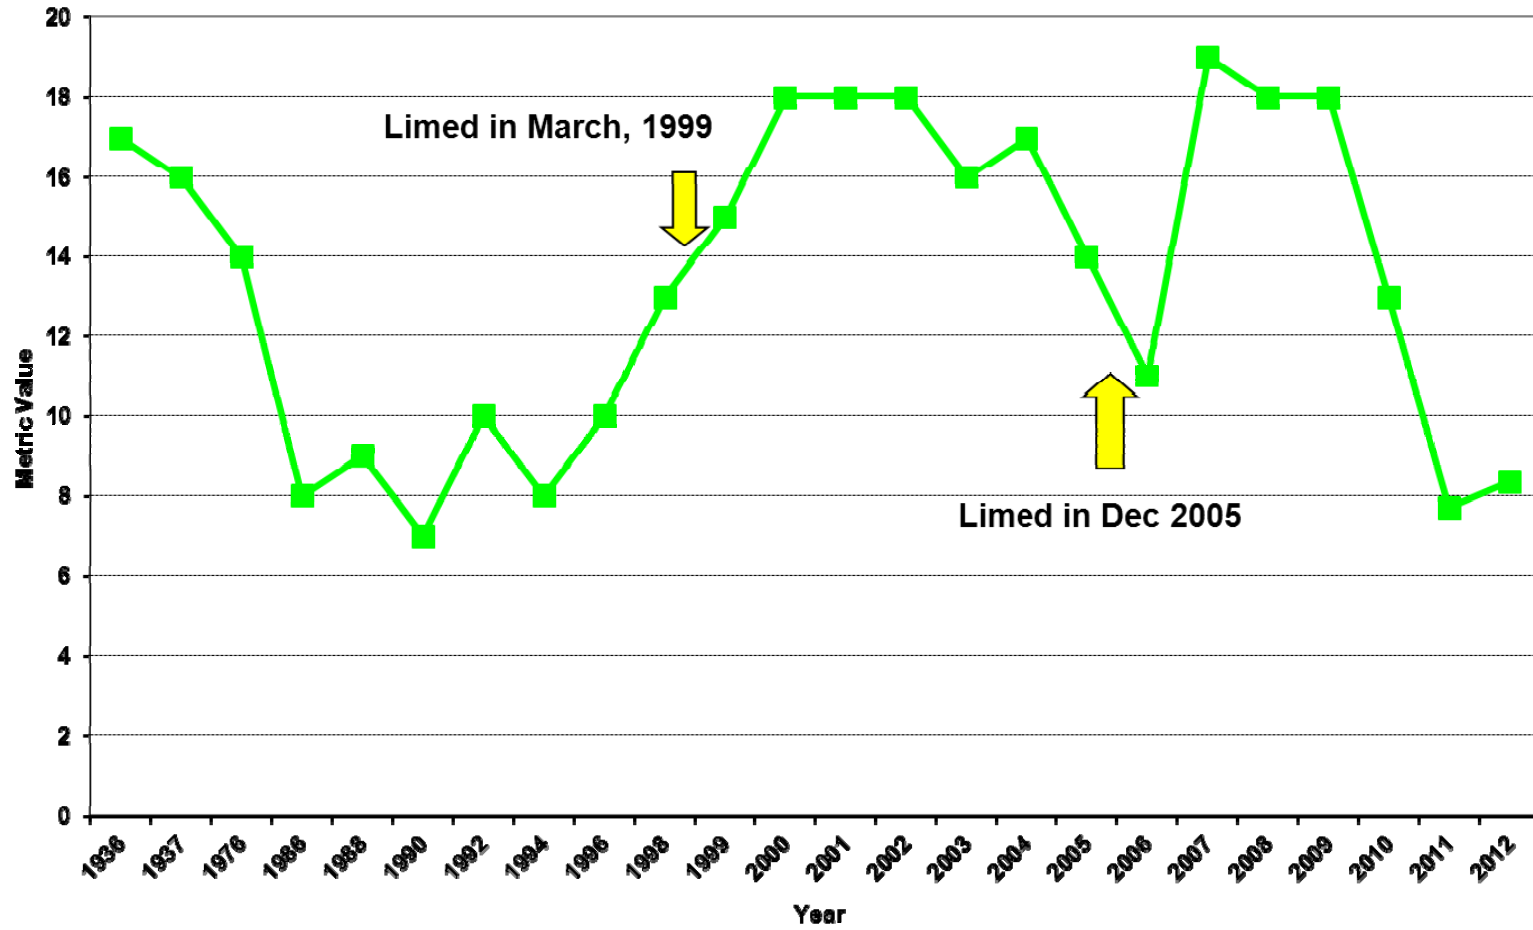
Ephemeroptera/Plecoptera/Trichoptera Index in St. Marys River

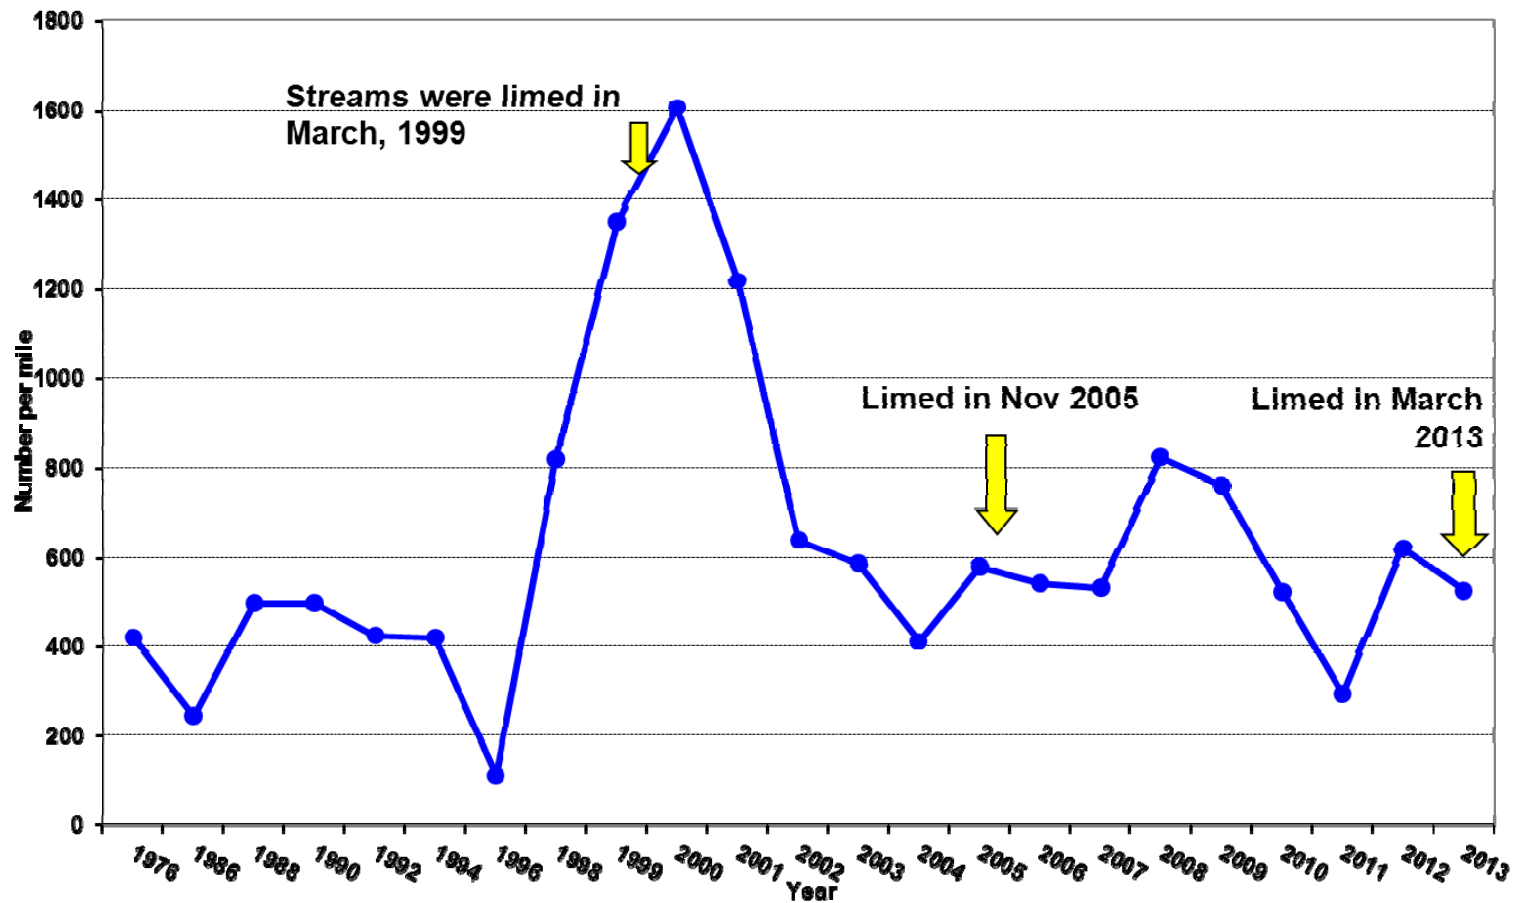
St. Marys Brook Trout Density

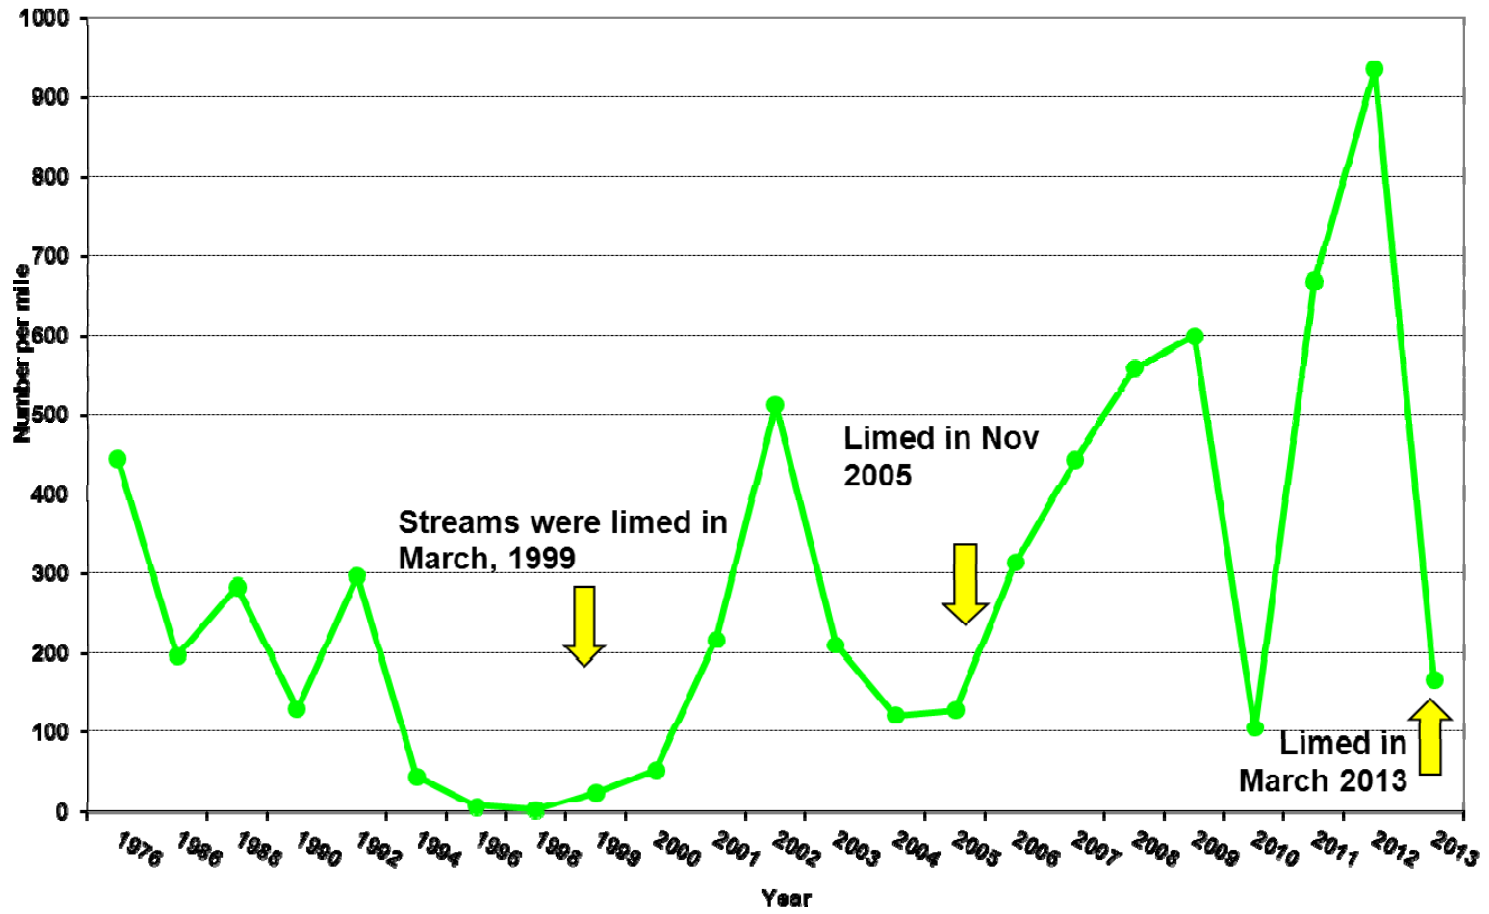
St. Marys Blacknose Dace Density

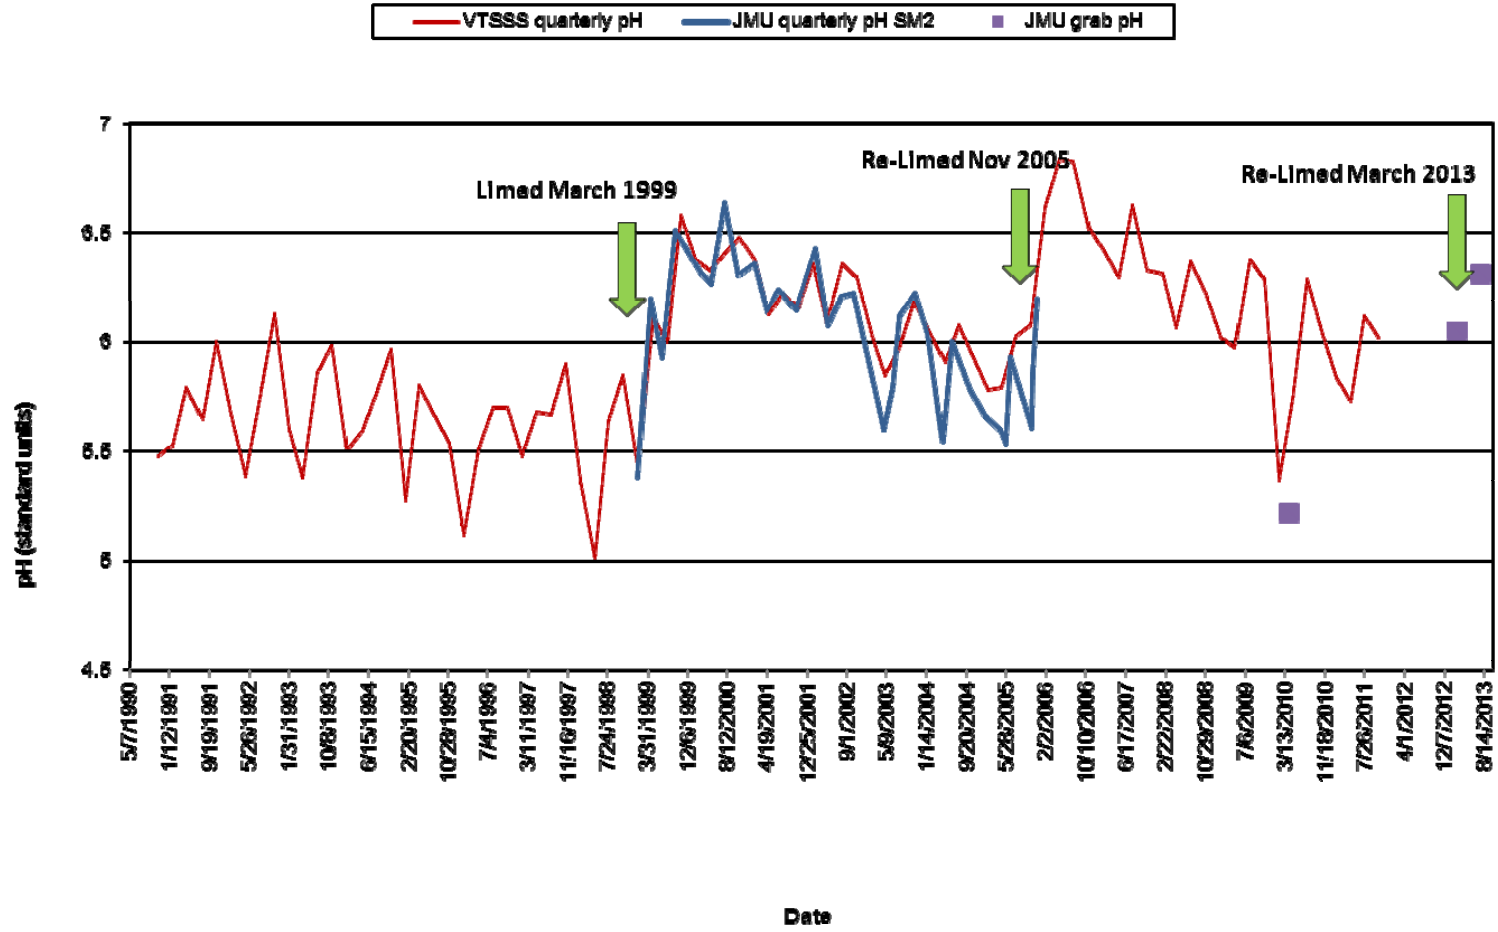
St. Mary's pH
